Field Performance  
Evaluation of  
Polymer Coated  
CSP Structures in

**N E W Y O R K**

**NATIONAL CORRUGATED  
STEEL PIPE ASSOCIATION**

*March 2002*

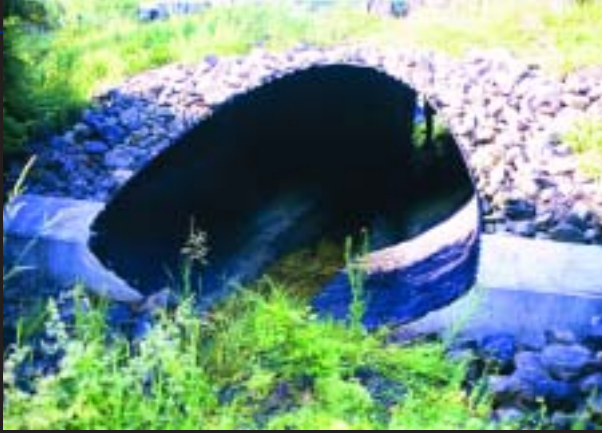
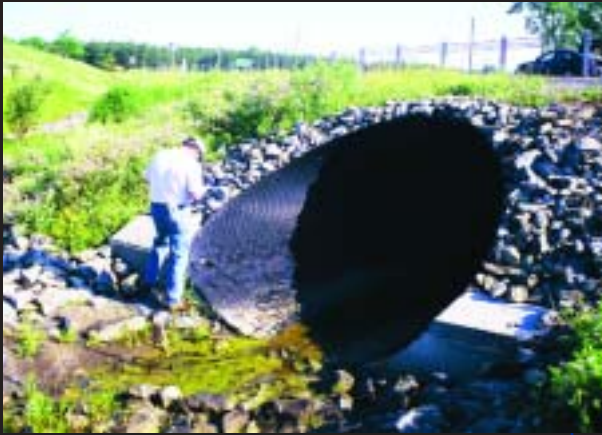
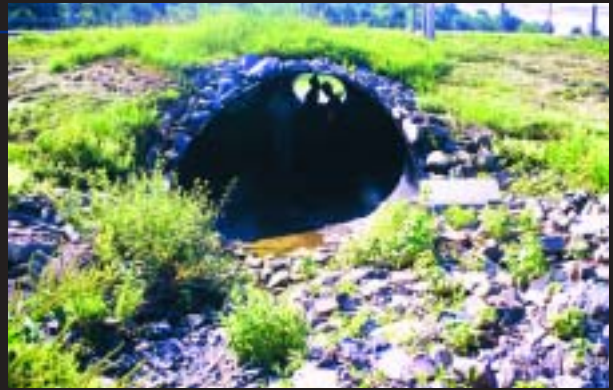
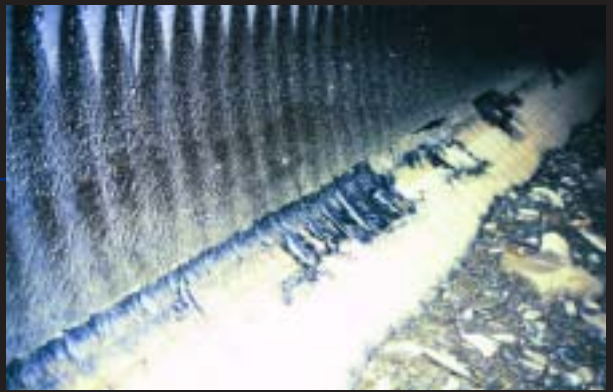
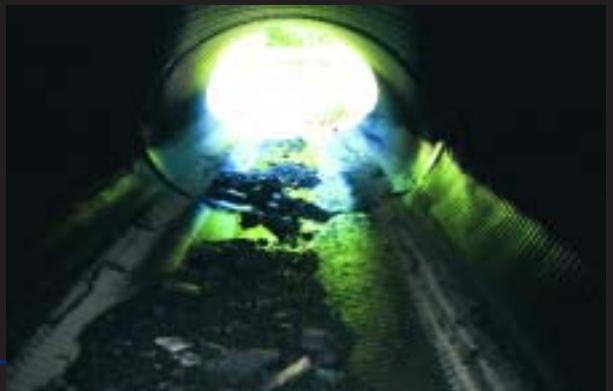
**COATING CONDITION.** The polymer coating was generally in excellent condition. In some locations along the cut edges, the polymer coating could be lifted from the galvanizing for approximately  $\frac{1}{4}$  inch. There was no metal loss at these edges. At all other locations the coating was well bonded. The asphalt was cracked at the ends of the paved invert where exposed to sunlight, but was well bonded to the polymer. No metal was exposed in the invert.

**COATING CONDITION.** The polymer coating was generally in excellent condition. However, there were gouges cut through the asphalt along both sides (worse on the south side). The straightness and symmetry of the gouges suggest a mechanical cause. Fresh asphalt was exposed, no metal or polymer coating damage was evident.

In some locations along the cut pipe edges, the polymer coating could be lifted from the galvanizing for approximately  $\frac{1}{4}$  inch. There was no significant metal loss at these edges. At all other locations the coating was well bonded. The asphalt paving was well bonded to the polymer coating.

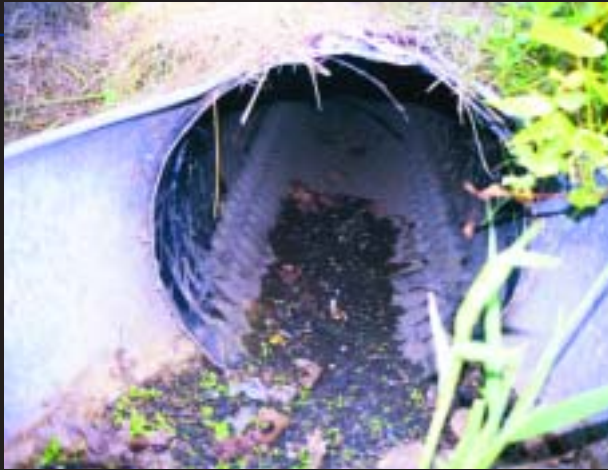
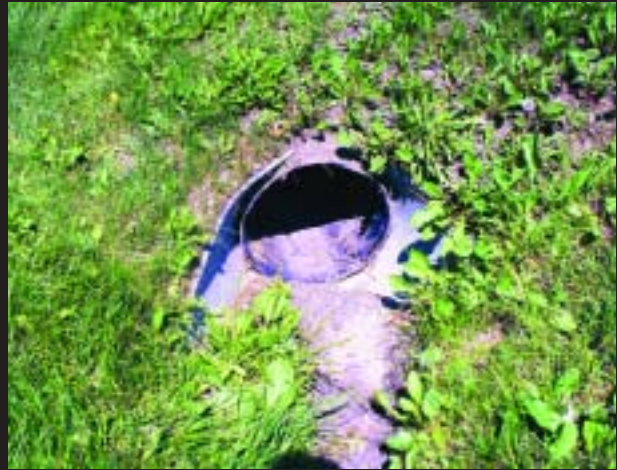
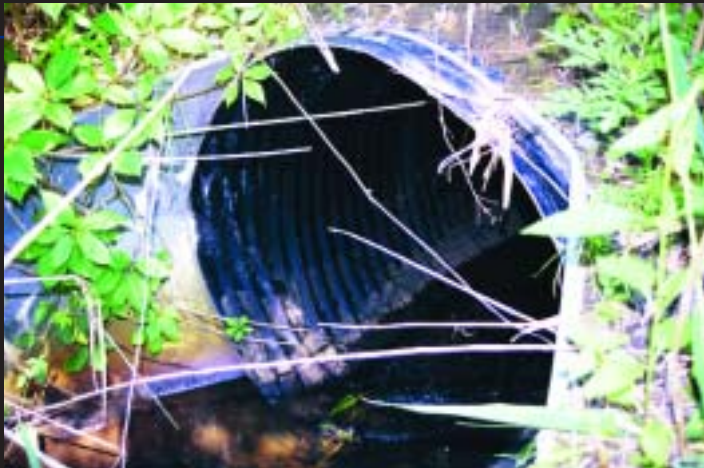
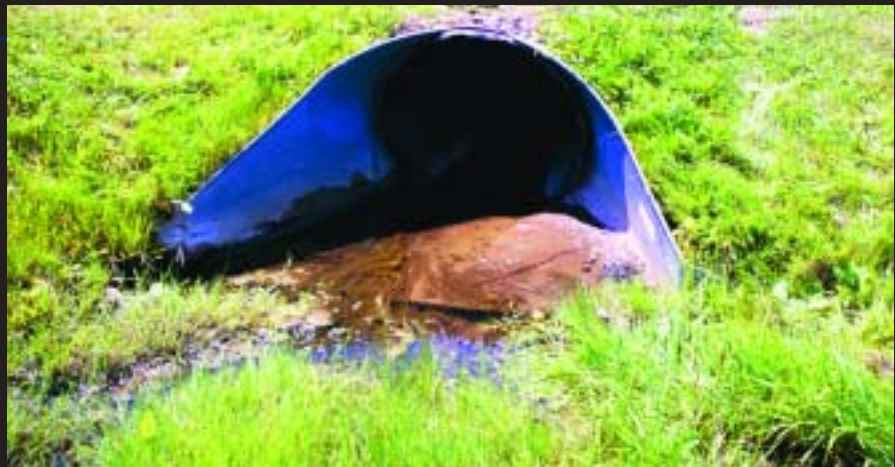
**COATING CONDITION.** The polymer coating was generally in excellent condition. The polymer coating was tightly adhered, even at the cut edges. The asphalt paving was cracked at the ends of the paved invert where exposed to sunlight, but was well bonded to the polymer. No metal was exposed in the invert.

**COATING CONDITION.** The polymer coating was generally in excellent condition. In some locations along the cut edges, the polymer coating could be lifted from the galvanizing for approximately ¼ inch. There was no significant metal loss at these edges. At all other locations the coating was well bonded. Where the field cuts were made, there was metal saw filings embedded in the polymer coating that exhibited corrosion. This should not be mistaken for corrosion of the substrate. The asphalt was well bonded to the polymer.

At the galvanized end section, all of the galvanizing was consumed and there was corrosion below the waterline. Above the waterline, the galvanized was in tact on the end sections.

**COATING CONDITION.** The polymer coating was generally in excellent condition. In some locations along the cut edges, the polymer coating could be lifted from the galvanizing for approximately ¼ inch. At the extreme bottom of the invert on one end, the coating could be lifted back as far as one inch. There was no significant metal loss at these edges. At all other locations the coating was well bonded. The asphalt was well bonded to the polymer. No metal was exposed in the invert.

The galvanized end section had some localized corrosion at the waterline, but was in generally good condition.

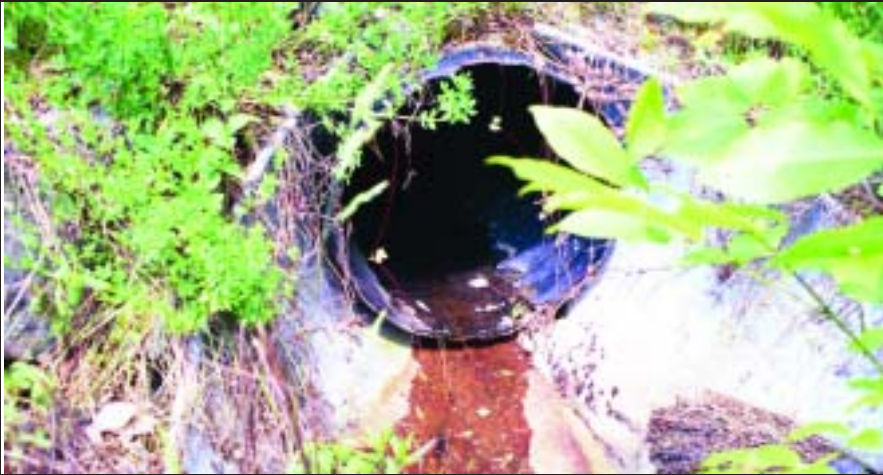
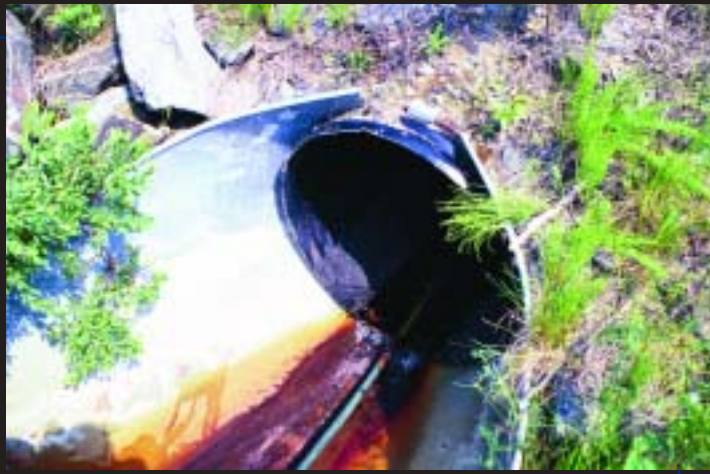
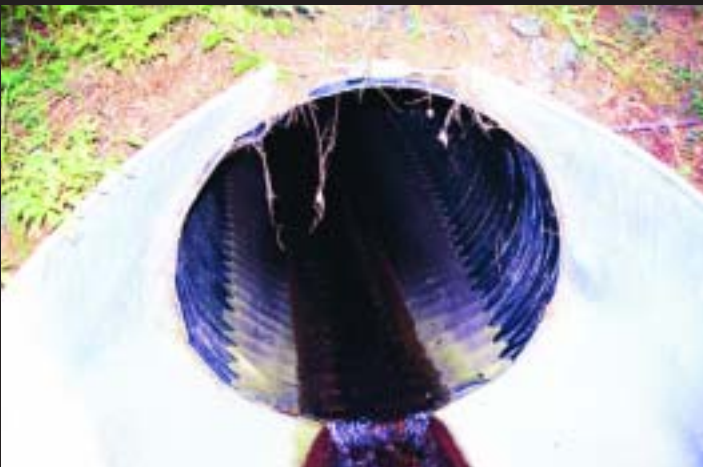
**COATING CONDITION.** The polymer coating was generally in excellent condition. In some locations along the cut edges, the polymer coating could be lifted from the galvanizing for approximately ¼ inch. There was no significant metal loss at these edges. At all other locations the coating was well bonded. On one side of the waterline at the outlet of the side drain, the coating could be lifted back as far as one inch. The asphalt was well bonded to the polymer.

The galvanized end section at the outlet of the side drain was perforated just above the waterline. This occurred immediately adjacent to the location where the polymer coating could be lifted up to one inch.

**COATING CONDITION.** The polymer coating was generally in excellent condition. In some locations along the cut edges, the polymer coating could be lifted from the galvanizing for approximately ¼ inch. There was no significant metal loss at these edges. At all other locations the coating was well bonded. The asphalt was well bonded to the polymer. No metal was exposed in the invert.

The galvanized end section had rust staining and some rusting steel in the invert. The staining made the extent of corrosion look slightly worse.

**COATING CONDITION.** The concrete pipe had approximately 1 inch of wear in the invert, exposing aggregate. The polymer coating was generally in excellent condition. In some locations along the cut edges, the polymer coating could be lifted from the galvanizing for approximately ¼ inch. There was no significant metal loss at these edges. At all other locations the coating was well bonded. The asphalt was well bonded to the polymer. No metal was exposed in the invert.

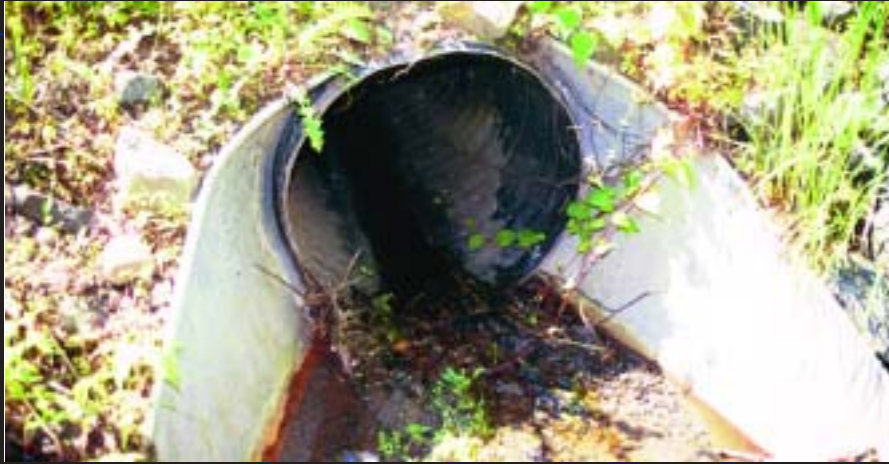
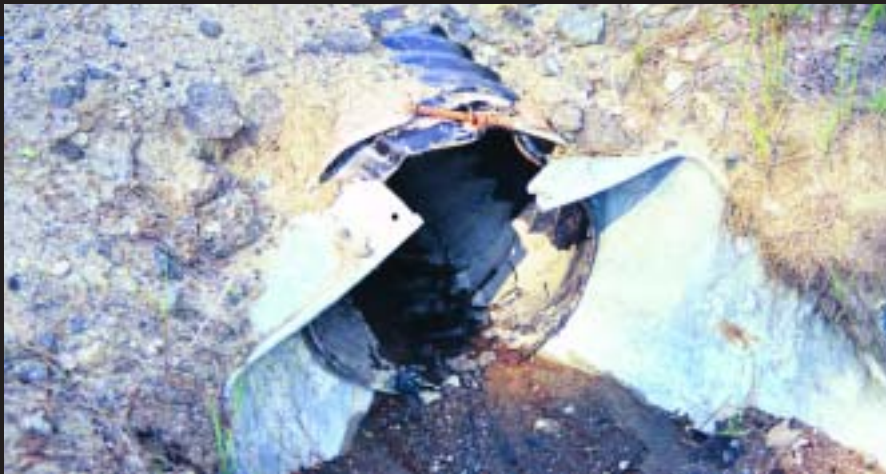
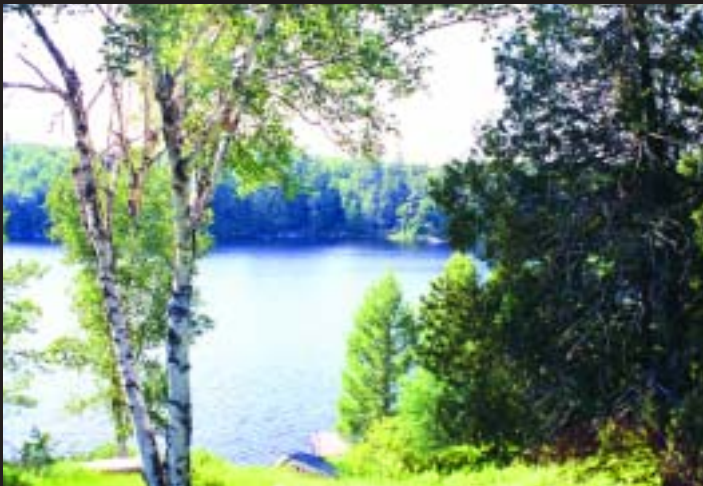
**COATING CONDITION.** The polymer was in good condition except for a small area of delamination at the cut edge — nominally 1 inch back along eight inches of edge just above the paved invert. The galvanized end section was rusting below the waterline and perforated in a small area.

**COATING CONDITION.** The polymer was well adhered and pliable. The paved invert was also well adhered, though some cracking existed at the exposed ends. No water or soil samples were taken.

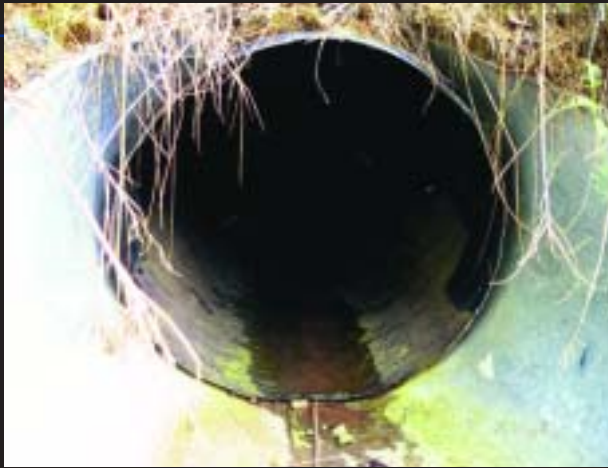
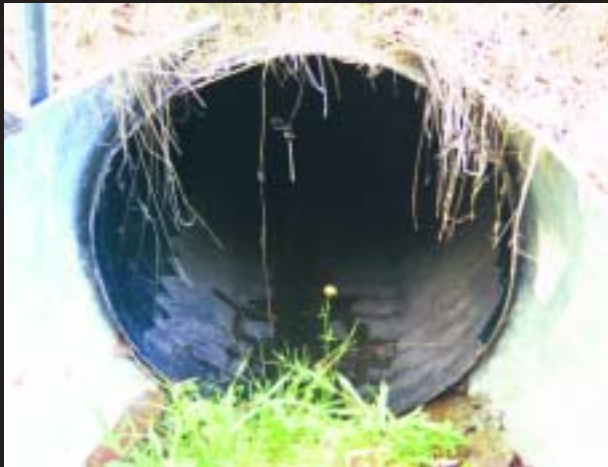
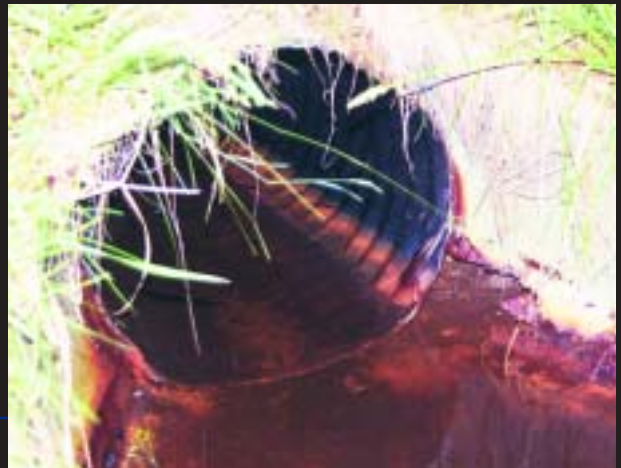
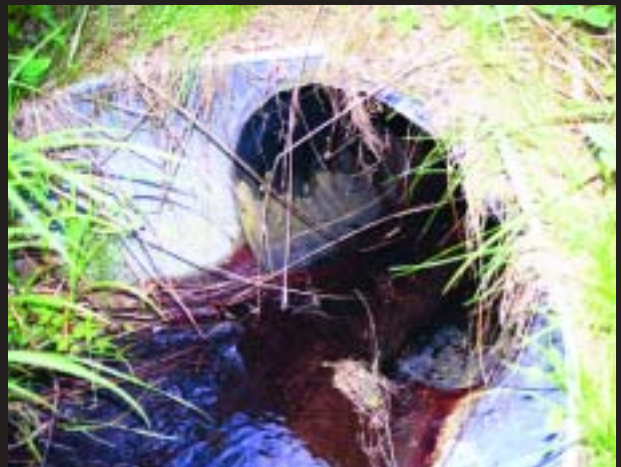
**COATING CONDITION.** The Paved invert was cracked for about the first foot on the exposed end. There was less than ¼ inch delamination from the cut ends. The galvanized end section had some minor corrosion in the invert.

**COATING CONDITION.** The polymer coating was generally in excellent condition. Even at the cut ends, the polymer coating was well adhered with the exception of a 4-inch length along what appeared to be a waterline. At this location approximately one inch of the polymer could be lifted. There was no corrosion under the small piece of delaminated film.

The outlet end section (galvanized) was totally perforated in the invert. The inlet end section was badly rusted with no obvious perforation.

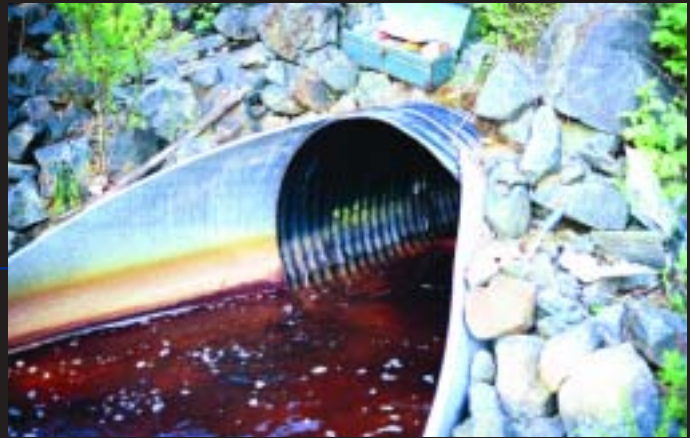
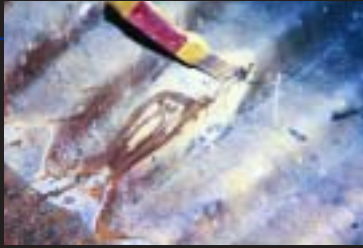
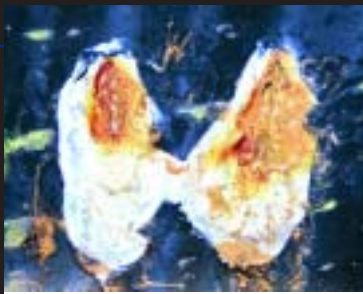
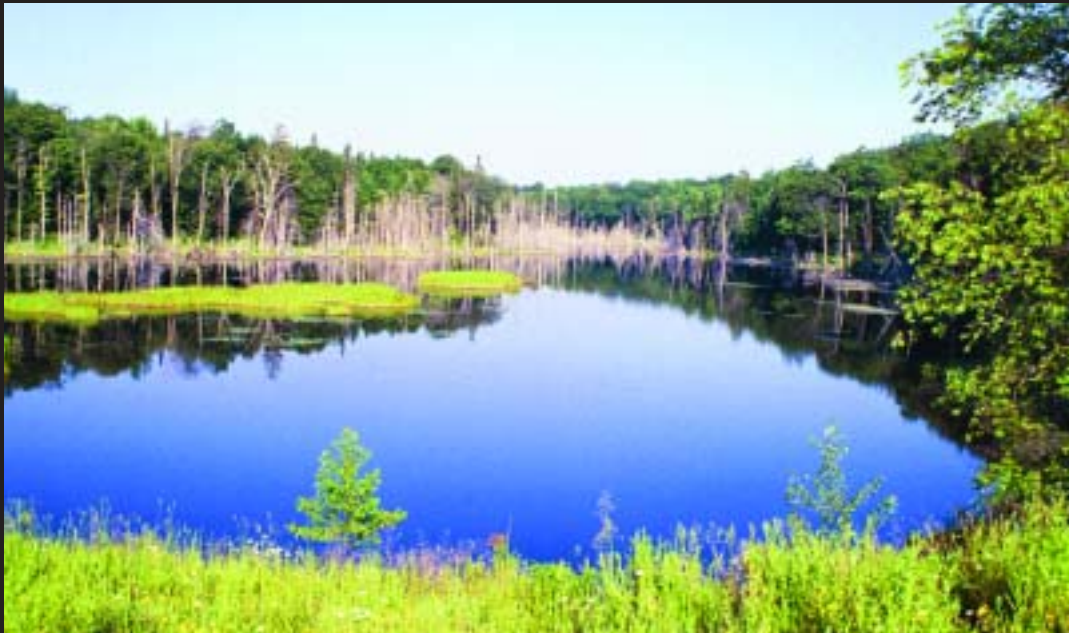
**COATING CONDITION.** The galvanized end sections were severely rusted with some perforations. Several blisters of varying sizes were noted in the polymer coating. They appeared to be worse at the typical water line on the south wall of the first section of pipe on the east, but they were noted at other locations. When the blistered polymer was removed, there were distinct slits up to three inches long, with adjacent corrosion occurring from the edges. The metal appeared to have been cut or gauged through to the polymer from the outside, though the inside film was intact. Based on the linear shape and distinctiveness of the steel loss, we do not believe this was due to corrosion. The steel must have been cut through the majority of its thickness prior to installation. Further investigation would be required to determine exactly what happened. It should also be noted that the environmental conditions at this site are most likely more aggressive than the data suggests. The soil sample was retrieved from the fill slope and not indicative of the corrosive soils behind the blisters. Also, bogs such as this tend to have lower pH and resistivity readings. There was active corrosion of the steel at the defects. It is of interest that this pipe is the only pipe to have an electrochemical potential less active than -600mV (-563mV), which is indicative of steel corrosion.

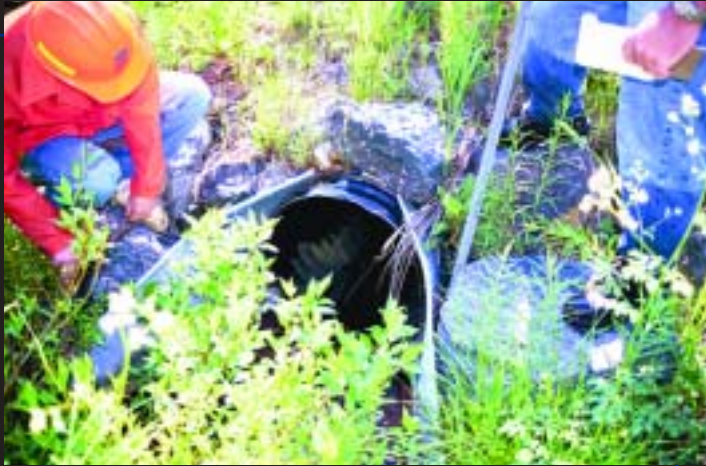
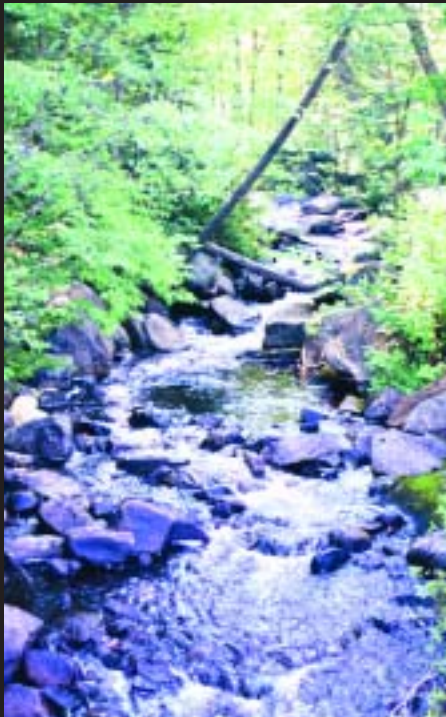
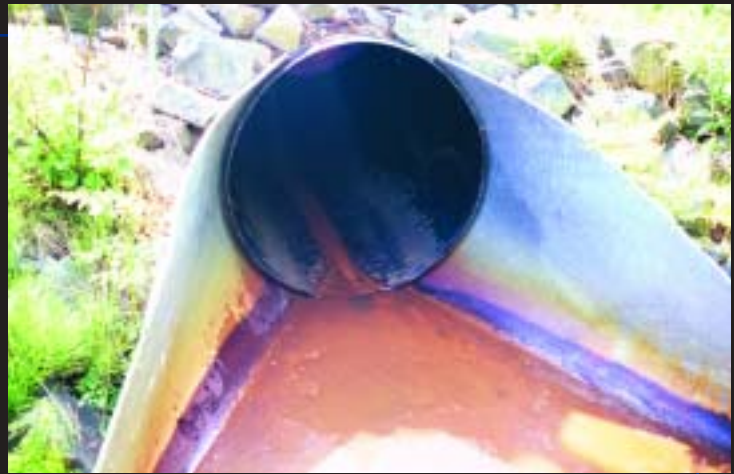
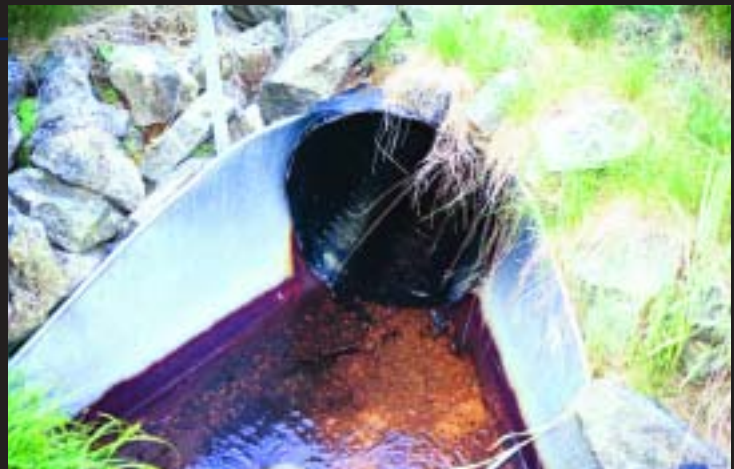
**COATING CONDITION.** The west end of the pipe was polymer coated and paved with a mechanical deformation in the top of the pipe approximately 3 feet from the end. The paved invert was cracked at the exposed end (approximately 1 foot). The paved invert was well adhered, though a small piece was removed near the end. The polymer was in excellent shape under the asphalt paving (e.g., well adhered, pliable, like new condition).

As a comparison, the east end of the pipe was asphalt coated and paved galvanized pipe. The paving had completely delaminated from 1-2 feet near the exposed end. The invert was rusting where the asphalt had come off. The galvanizing was in good shape where the asphalt was still intact.

**COATING CONDITION.** The polymer coating had some mechanical damage, but was well adhered. The asphalt paving was well adhered inside with some mechanical damage and cracking at the exposed ends. One of the cut ends in the pipe interior has a few square inches of delamination from the cut edge in the invert.

As a comparison, the galvanized bands were severely corroded in the invert with some perforation, especially around the water line. The galvanized end sections were both rusted in the invert; the inlet (west) end was perforated in some locations.

**COATING CONDITION.** The polymer coating was generally in excellent condition. In some locations along the cut edges, the polymer coating could be lifted from the galvanizing for approximately ¼ inch. There was no significant metal loss at these edges. At all other locations the coating was well bonded. The asphalt was cracked at the ends of the paved invert, but was well bonded to the polymer. No metal was exposed in the invert.

The galvanized end sections showed corrosion in the invert.

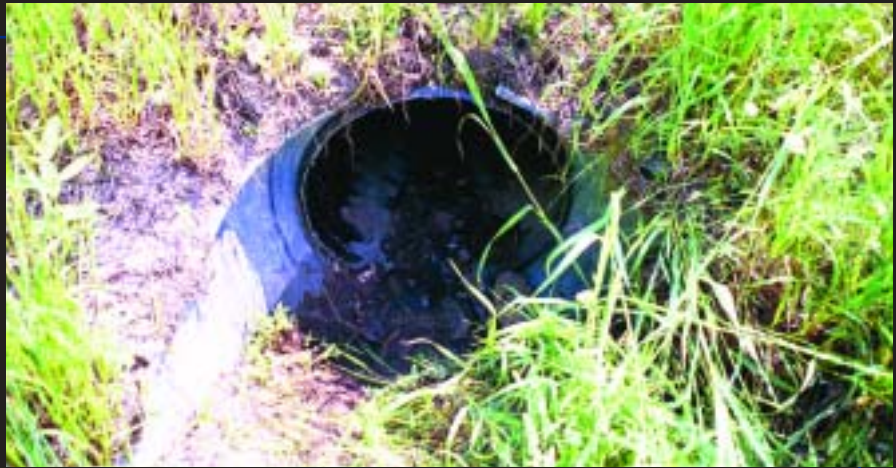
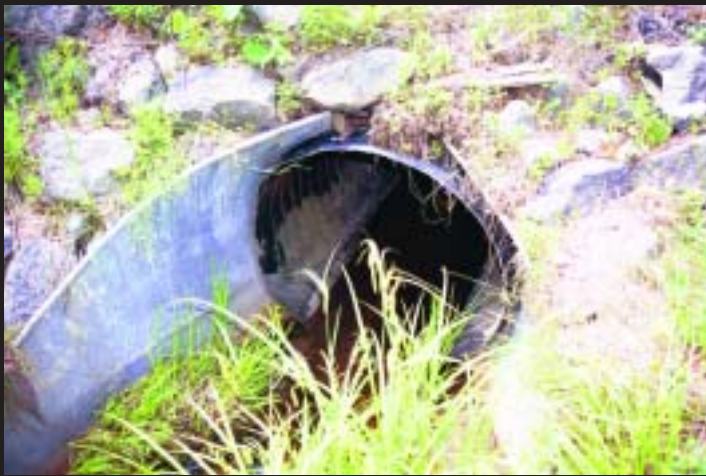
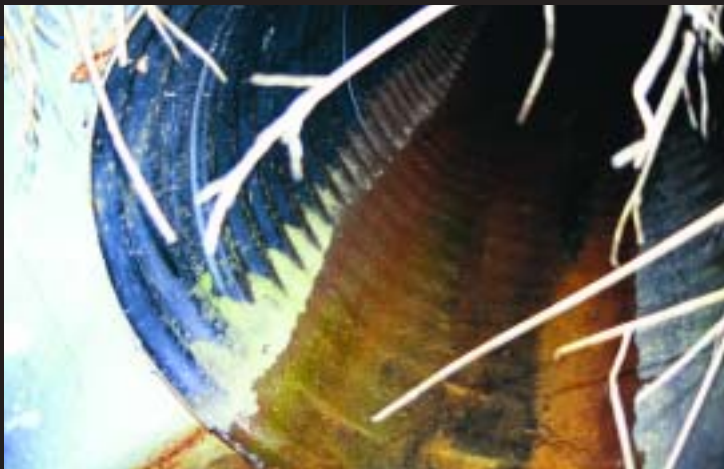
**COATING CONDITION.** The polymer coating was generally in excellent condition. The polymer coating is well bonded, even at the pipe edges. There was no significant metal loss at these edges. The asphalt was well bonded to the polymer. No metal was exposed in the invert.

**COATING CONDITION.** The inlet end of the pipe was polymer coated and asphalt paved. The polymer coating was generally in excellent condition. In some locations along the cut edges, the polymer coating could be lifted from the galvanizing for approximately 1/2 inch. There was no significant metal loss at these edges. At all other locations the coating was well bonded. The asphalt was cracked at the ends of the paved invert, but was well bonded to the polymer. No metal was exposed in the invert.

The outlet end of the pipe was asphalt coated galvanized steel. The asphalt and galvanizing was almost completely removed below the waterline. The steel was actively corroding, but still sound.

The galvanized end sections had active corrosion below the waterline but were not perforated.

**COATING CONDITION.** The polymer coating is in good shape. The paved invert is cracking at the exposed ends, but is intact. The galvanized pipe is rusting below the waterline. Both end sections are rusting below the waterline.
