# Durability Analysis of Aluminized Type 2 Corrugated Metal Pipe

PUBLICATION NO. FHWA-RD-97-140

JANUARY 2000

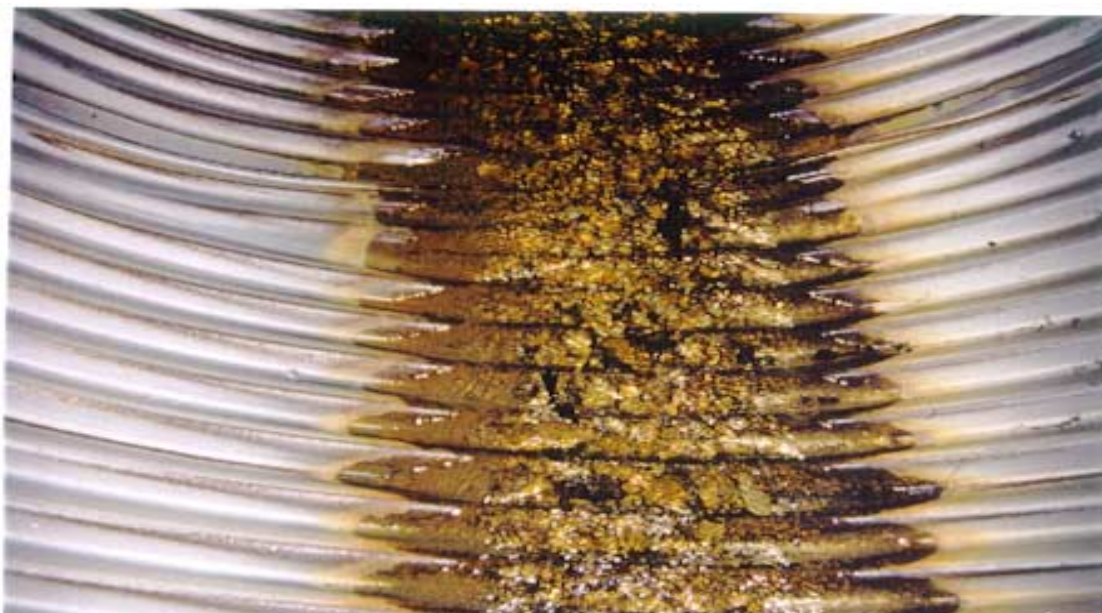
Locations 310.0 and 310.1 were the only two culverts at the Natchez Trace Parkway that were experiencing any kind of flow conditions at the time of the inspection. A possible alternative explanation for the advanced deterioration is a synergistic effect of the potentially corrosive Alabama soils and incidence of abrasion. The wear pattern on these culverts is indicative of the type of deterioration that occurs as a result of abrasive wear. This wear occurs predominantly on the upstream tangents of the corrugations. Figure 4 shows the interior of 310.0. Figure 5 shows a close-up of the invert of this culvert. Notice in both photos that the exposed steel and apparent rusting is more significant on the upstream side of the corrugation. This is consistent with

Figure 4. Culvert at 310.0 (flow is from bottom of photo to the top).

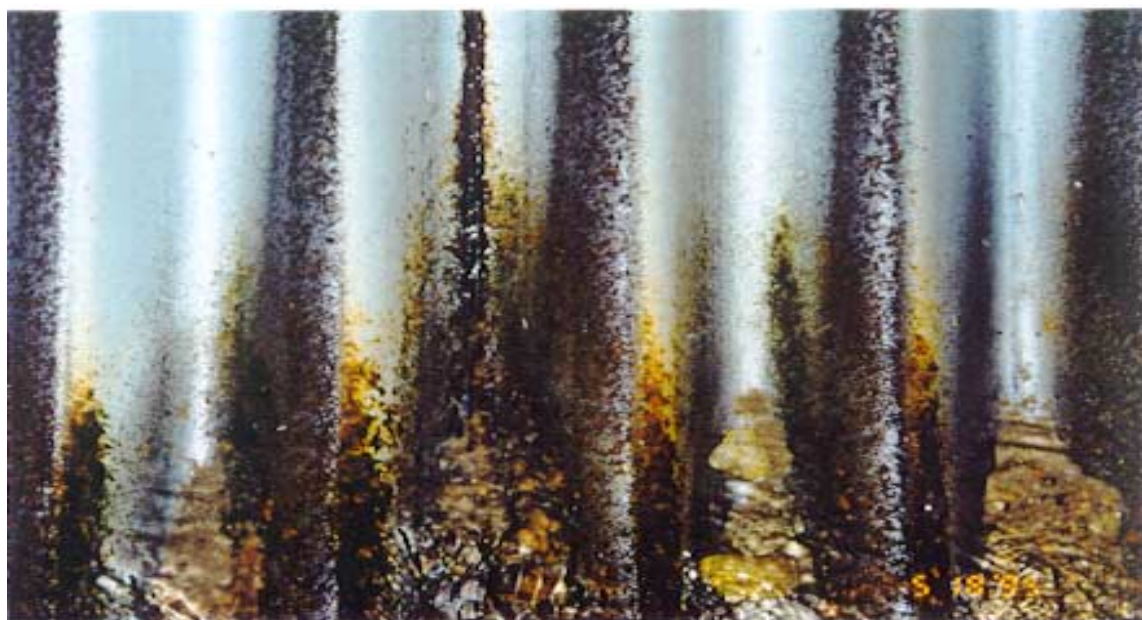
abrasive damage. Chemical attack would be expected to affect both sides equally, as shown in figure 6, which is a photo of an Aluminized Type 2 pipe (not in this study) exposed to an aggressive environment in the absence of abrasion.

Figure 5. Close-up of 310.0 (flow is from left of photo to right).  
Note: Wear and corrosion predominate on upstream side of corrugation.

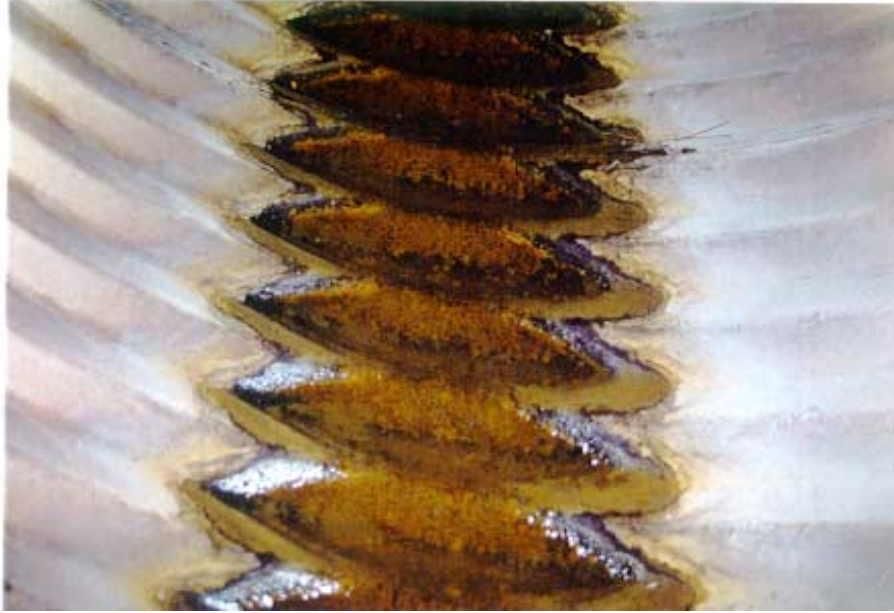
Figure 6. Aluminized Type 2 culvert after 5.5 years exposed to runoff with a pH of 2.5 to 3.5 (not from this study).

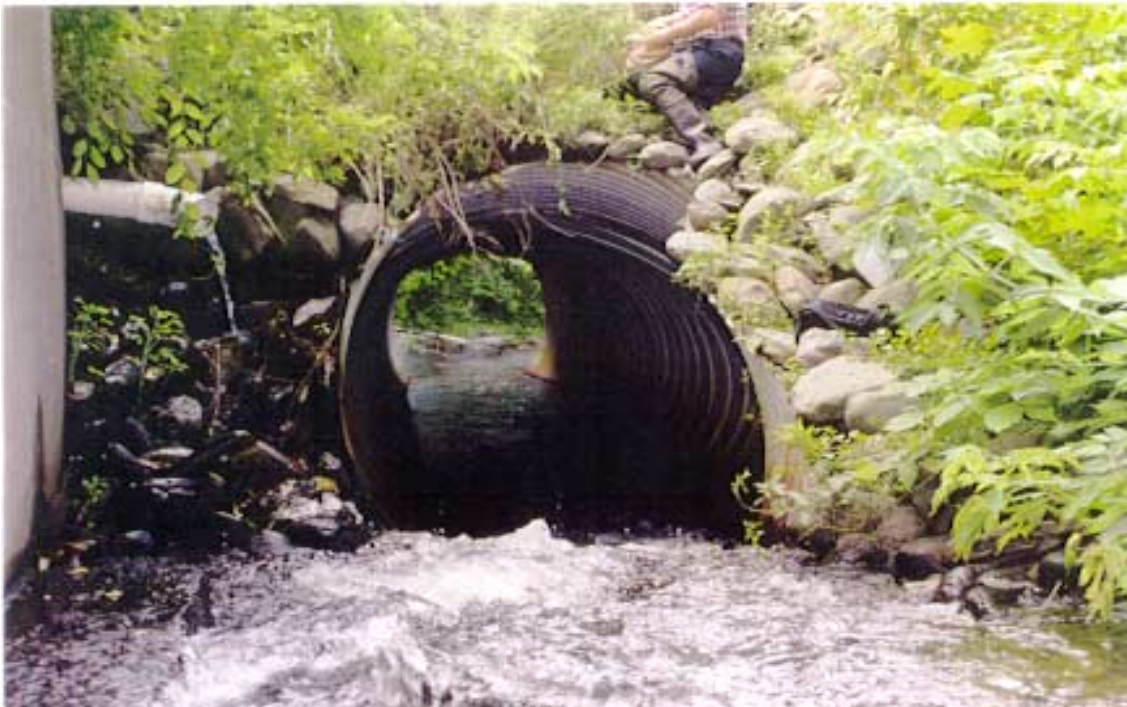
The third data outlier is that from the location in Dexter, Maine. This culvert is experiencing the highest abrasion of any of the Aluminized Type 2 pipes in this investigation. A high-velocity flow passes through this culvert carrying a rock bed load. Figure 7 shows an overview of the Dexter culvert.

Figure 7. Culvert at Dexter, Maine, experiencing high-velocity flow.

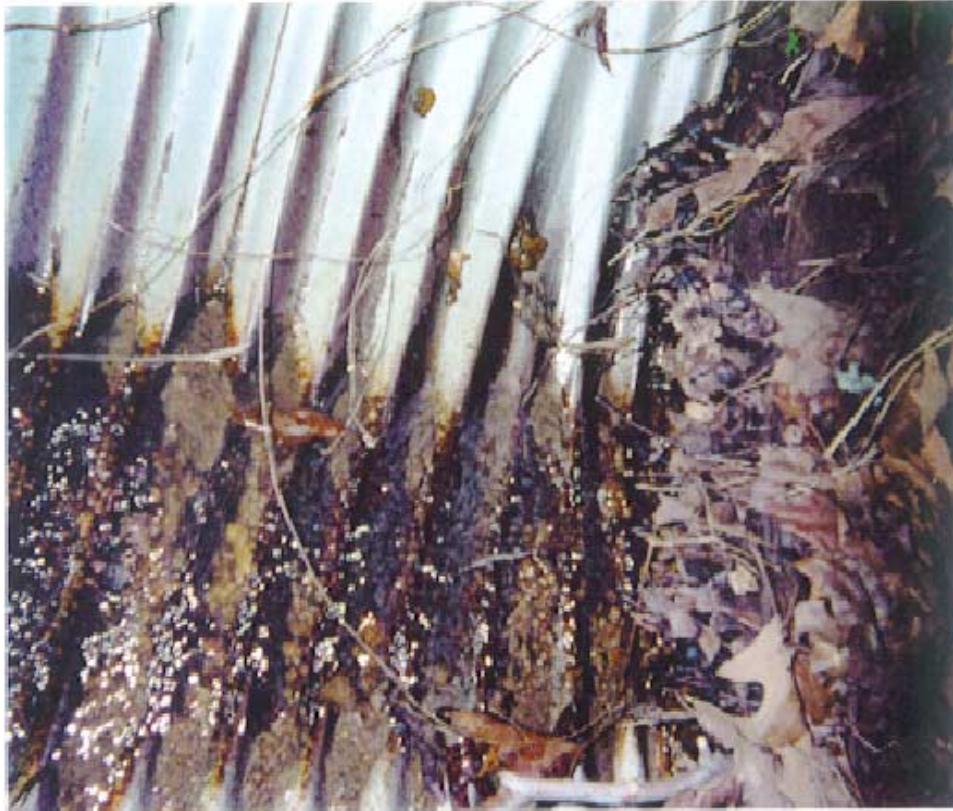
Figure 17. Inlet of the pipe at 309.4.

Table 10. Water chemistry observed at location 309.4.

Conductivity	77 $\mu$ S/cm
PH	7.1 @ 11.1°C (52°F)
Chlorides	7.5 mg/L
Alkalinity	19 mg/L
Carbon Dioxide	2.2 mg/L
Calcium Hardness	15.4 mg/L
Total Hardness	31 to 55 mg/L
