Polymeric Coated Corrugated Steel Pipe Durability Study

Update: October 27, 2016

Field Performance of Polymer Coated CMP
Cass County Minnesota
State Hwy 84 Pine River, MN to Longville, MN

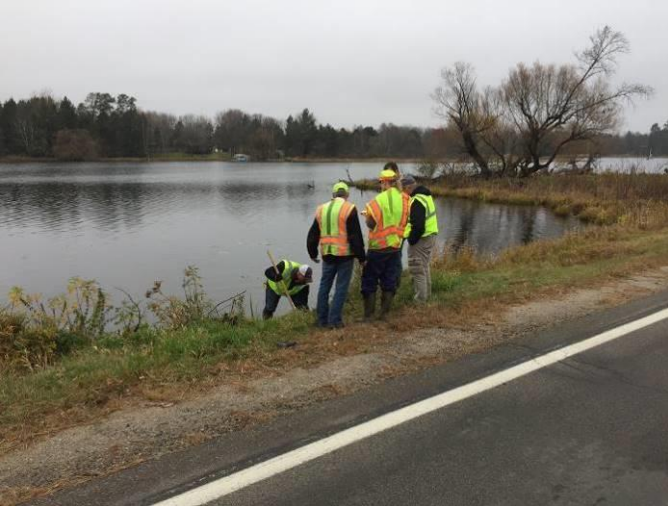
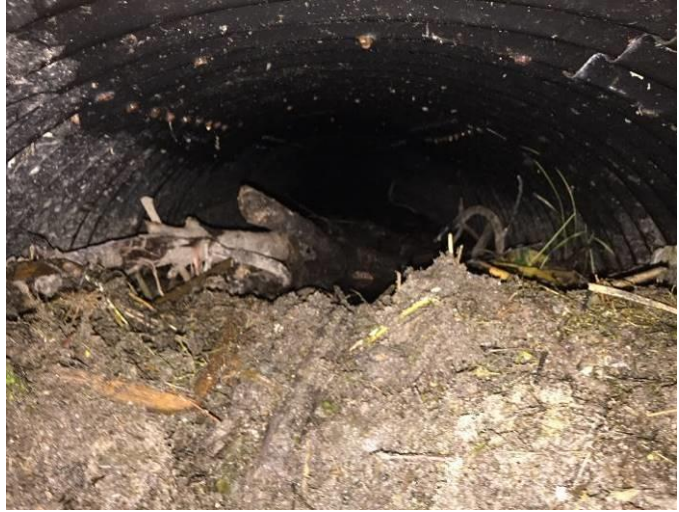
Location #1 at mile post 0.60 – single 28" X 20" Pipe Arch Shape

Pipe Rating – Unknown 0 (Not able to rate, not visible). Most of the pipe was submerged with beaver dam on the downstream end. The top of the culvert was visible and looked in good condition.

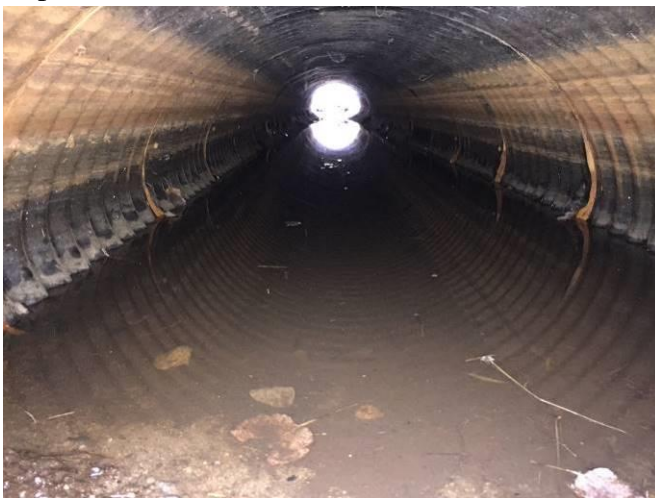
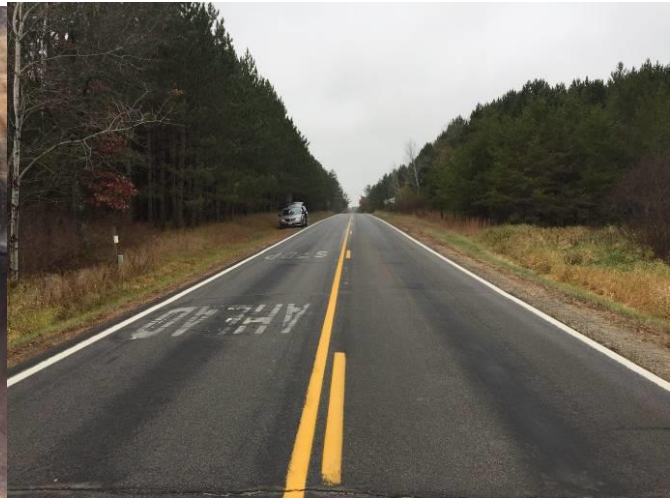
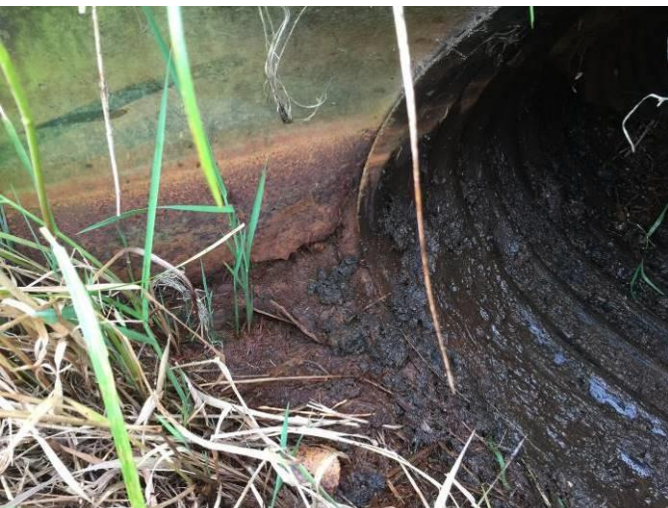
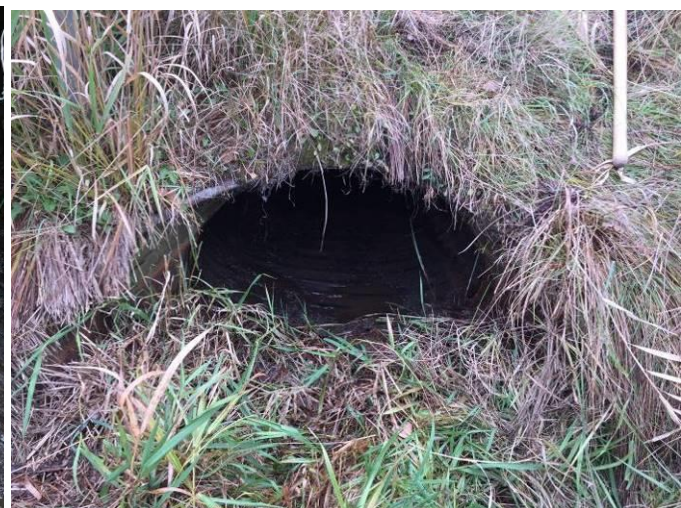
Location #2 at mile post 2.60 – 35" X 29" Pipe Arch Shape

Pipe Rating – Still Okay 2 (Fair - some wear, but structurally sound) Site was wet with some standing water in the pipe culvert. The outlet end required cleaning. The galvanized end section was rusted through. The polymer culvert was in good shape with minor delamination at a few riveted seams.

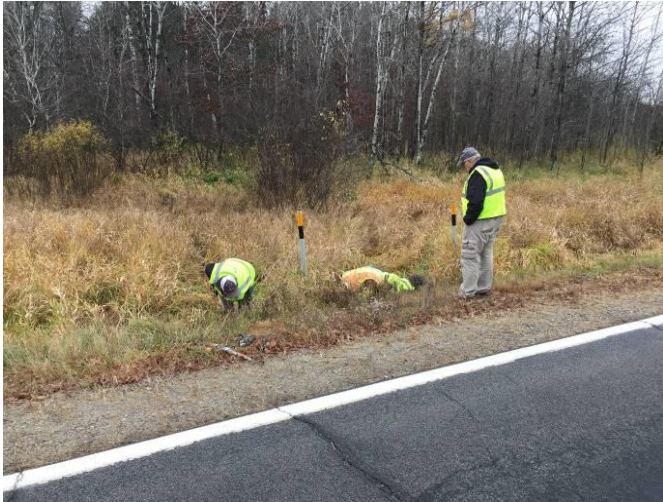
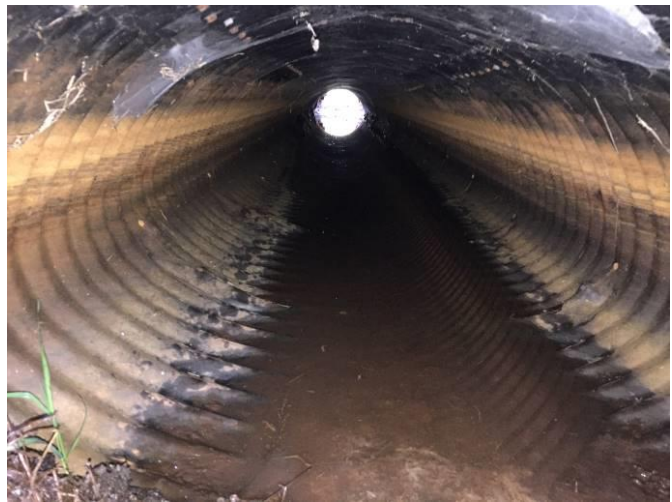
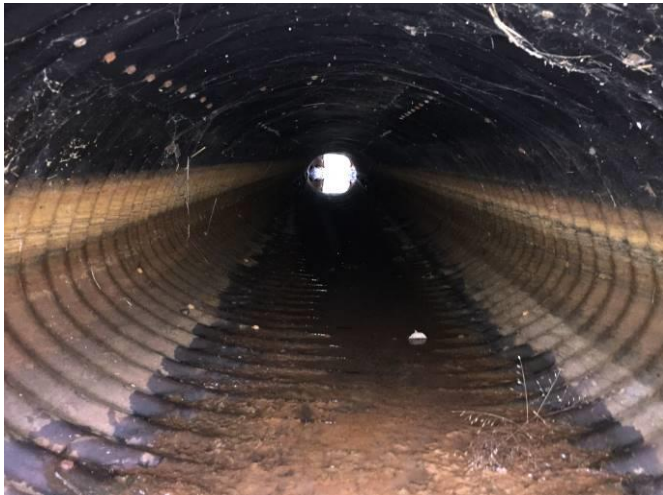
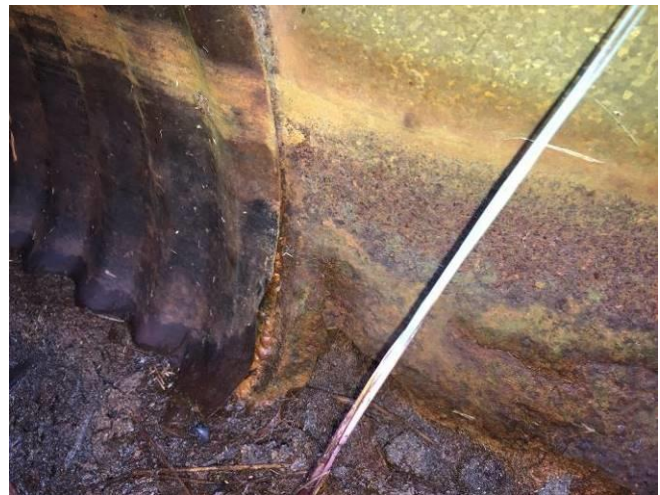
Location #3 at mile post 2.61 – 35" X 29" Pipe Arch Shape

Pipe Rating – Still Okay 2 (Fair - some wear, but structurally sound). The site was wet with some standing water in the pipe culverts. The galvanized end section was rusted through. The polymer culvert was in good shape with minor delamination on the inlet end.

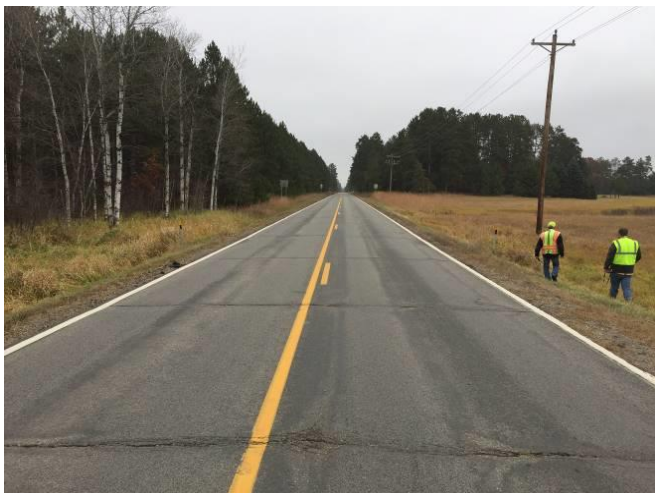
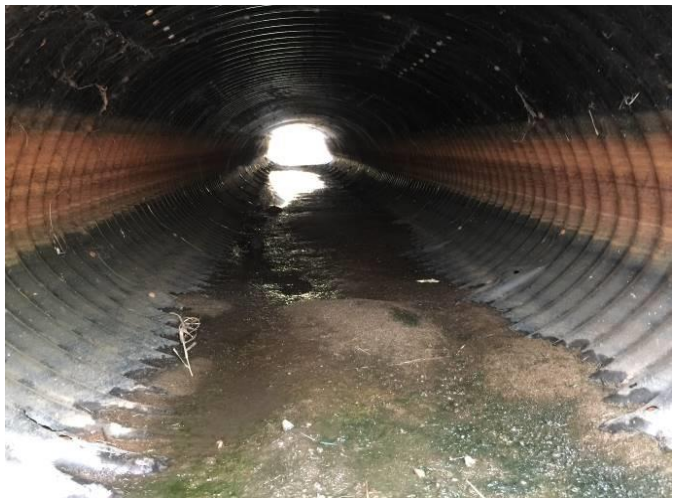
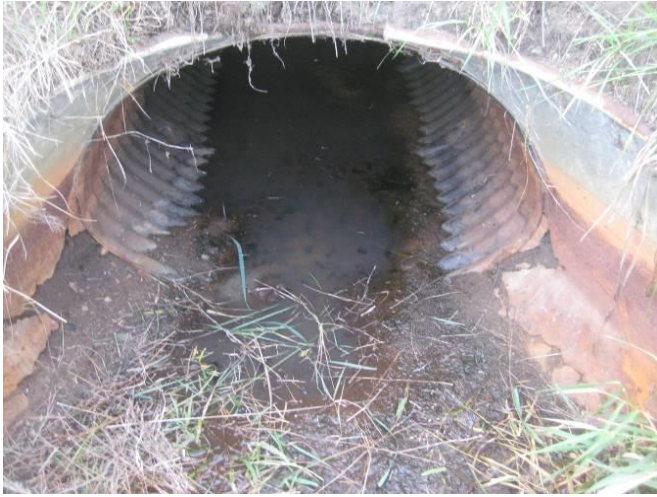
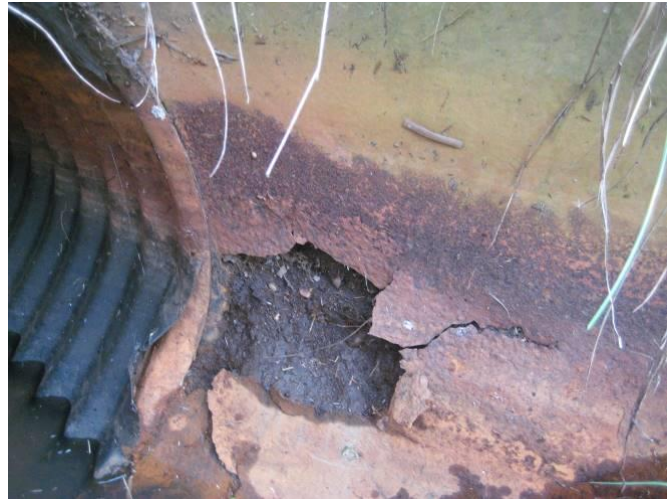
Location #4 at mile post 2.73 – 42" X 29" Pipe Arch Shape

Pipe Rating – Still Okay 2 (Fair - some wear, but structurally sound). The pipe appeared to be in good shape with minor delamination at a few riveted seams. The galvanized end section was rusted through.

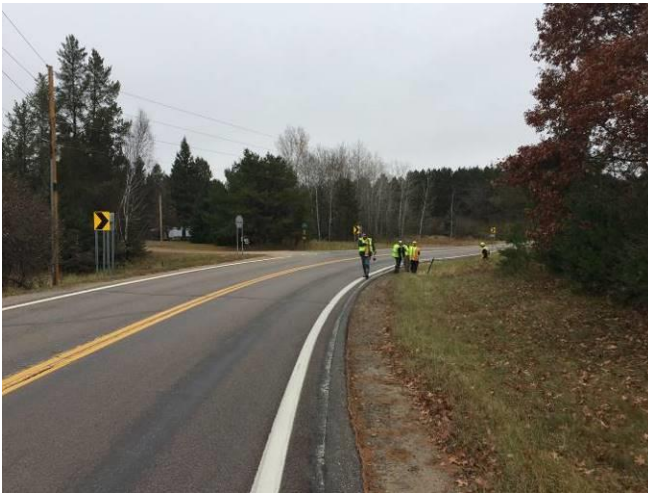
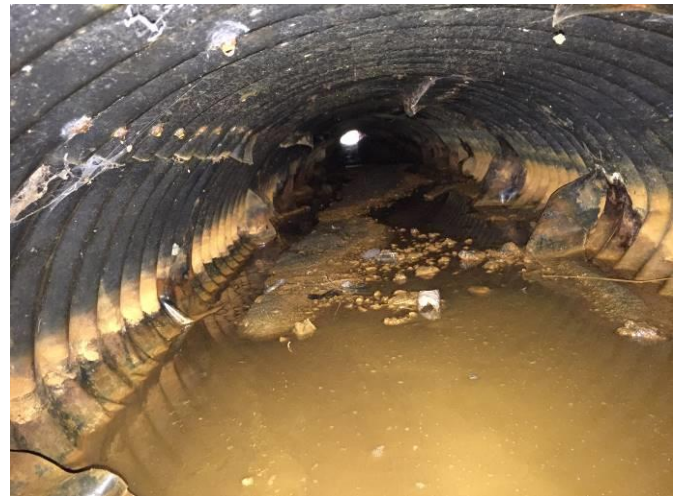
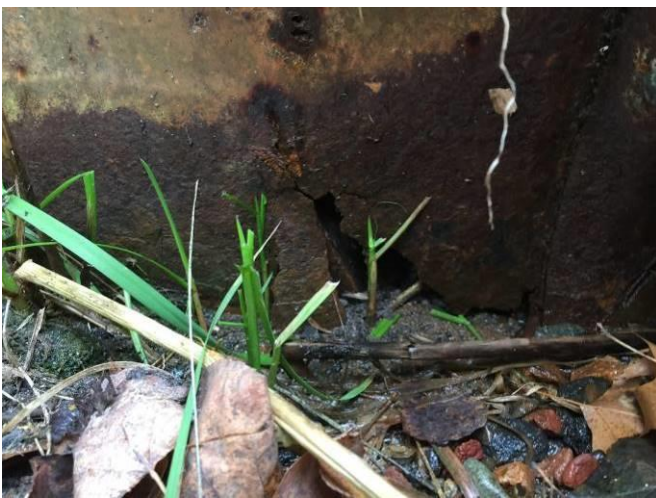
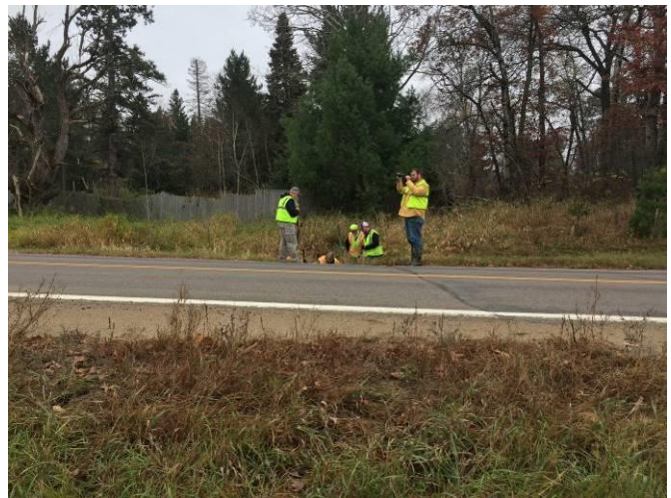
Location #5 at mile post 12.81 – 28” X 20” Pipe Arch Shape

Pipe Rating – Still Okay 2 (Fair - some wear, but structurally sound). There was delamination throughout the culvert, however no perforations were in the base steel of the culvert. The galvanized end section did show corrosion with pitting through the steel.

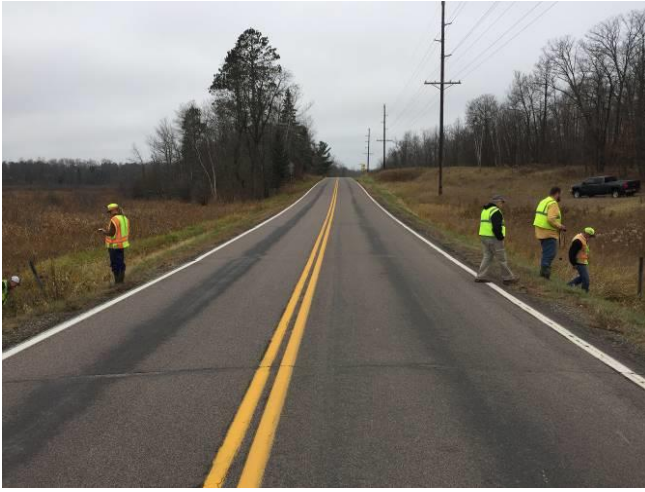
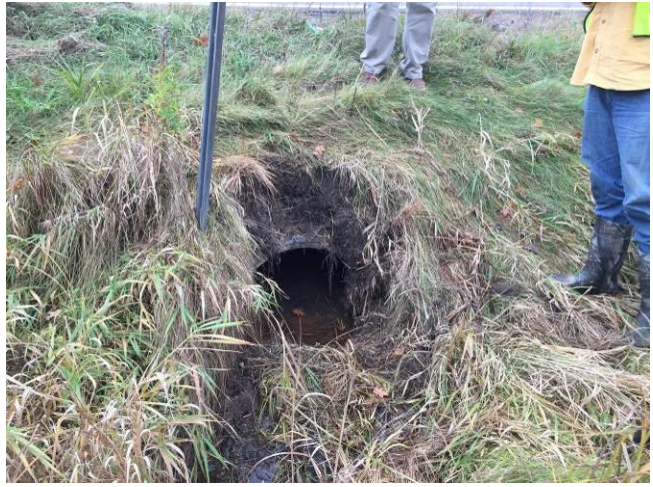
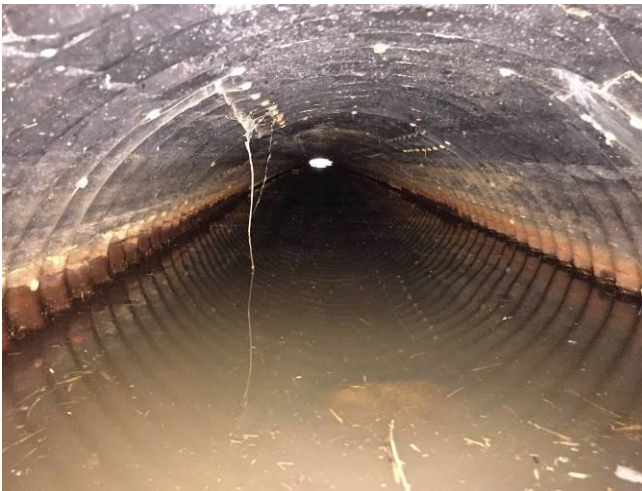
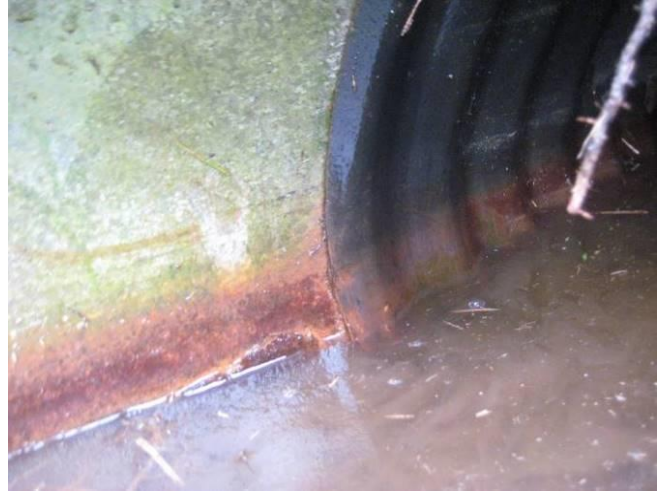
Location #6 at mile post 17.55 – 28” X 20” Pipe Arch Shape

Pipe Rating – Still Okay 2 (Fair - some wear, but structurally sound). The pipe had standing water on the outlet end. The pipe coating was in good condition. The polymer coating is adding service life to the culvert based on the condition of the galvanized end section.

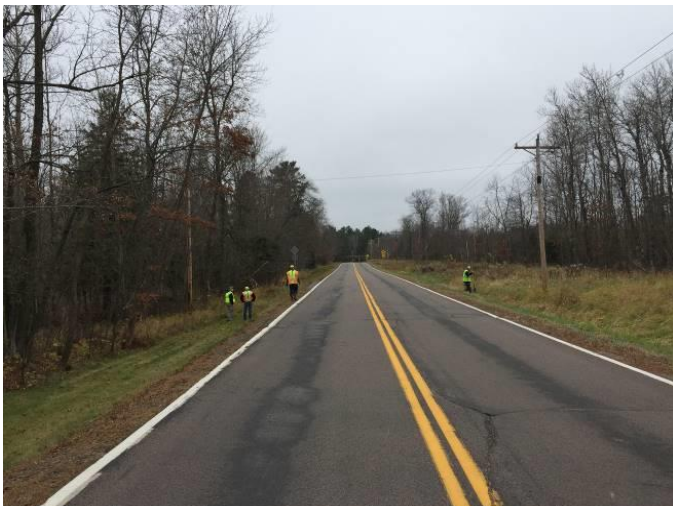
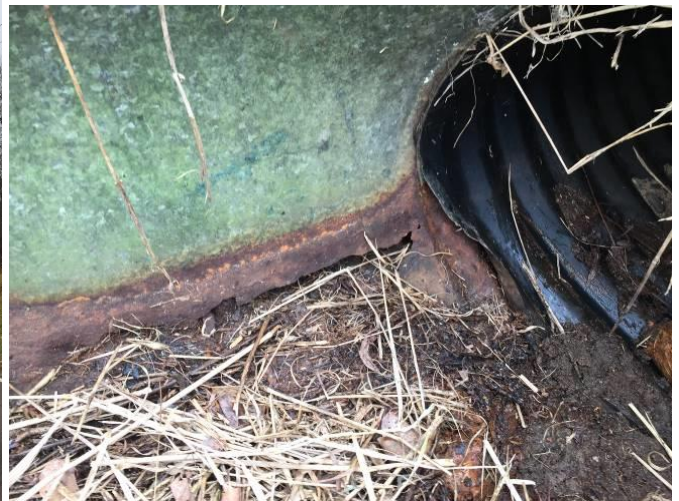
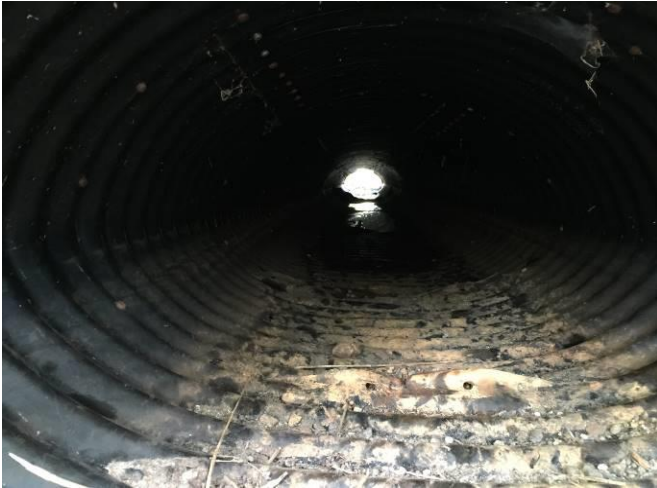
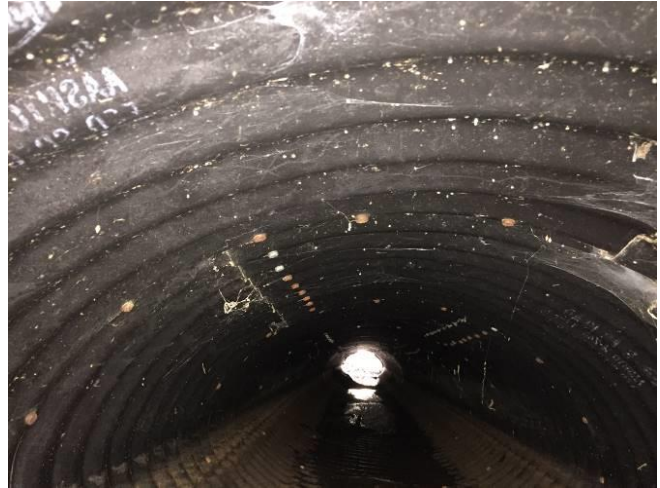
Location #7 at mile post 18.48 – 28” X 20” Pipe Arch Shape

Pipe Rating – Still Okay 2 (Fair - some wear, but structurally sound). The pipe was in good shape with minor delamination on the inlet end and at a few seams. The galvanized end section was rusty through.

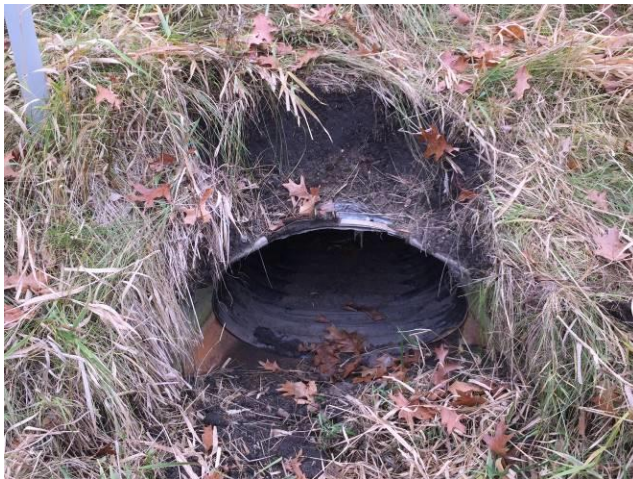
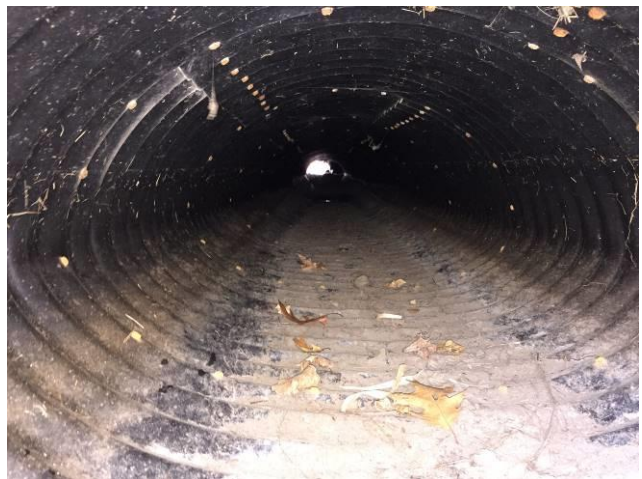
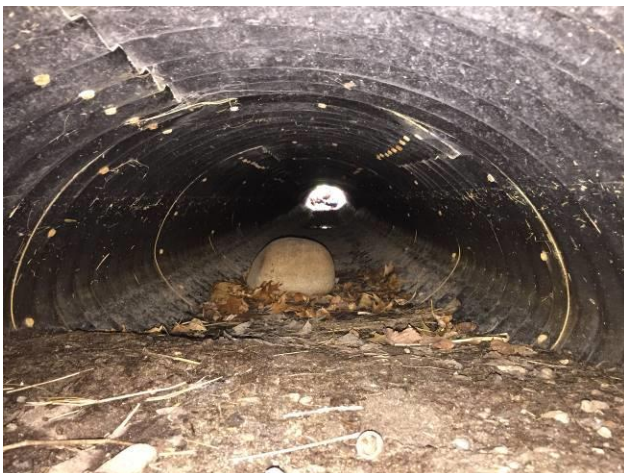
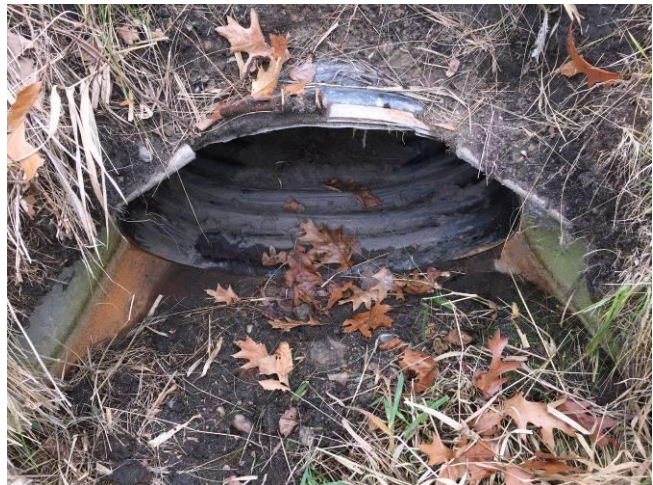
Location #8 at mile post 18.83 – 28" X 20" Pipe Arch Shape

Pipe Rating – Still Okay 2 (Fair - some wear, but structurally sound). There was sediment in the outlet of the pipe with a boulder resting in the invert. The outlet had sediment which needed to be cleaned for observation of the invert. The polymer coated pipe is in good shape. The galvanized end section is showing corrosion. Most of the culvert was dry at time of inspection.

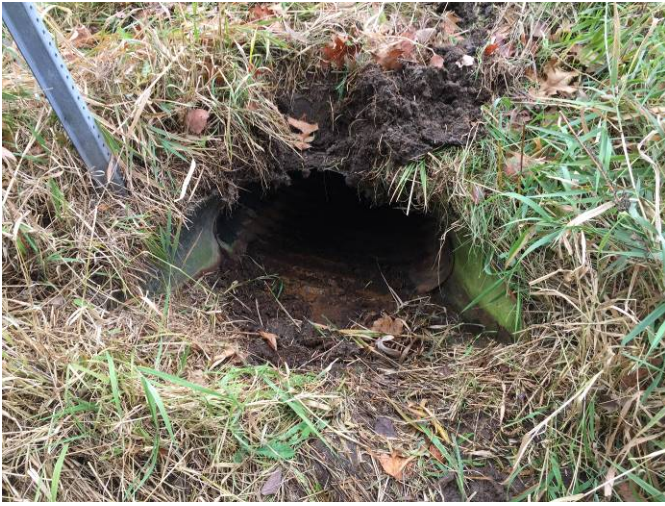
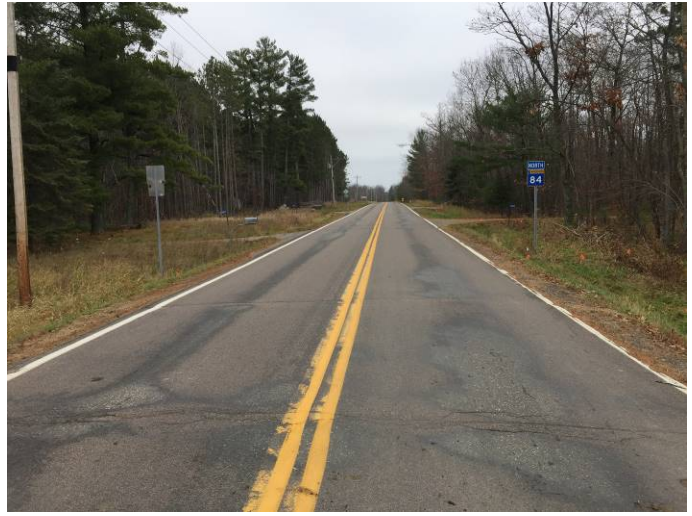
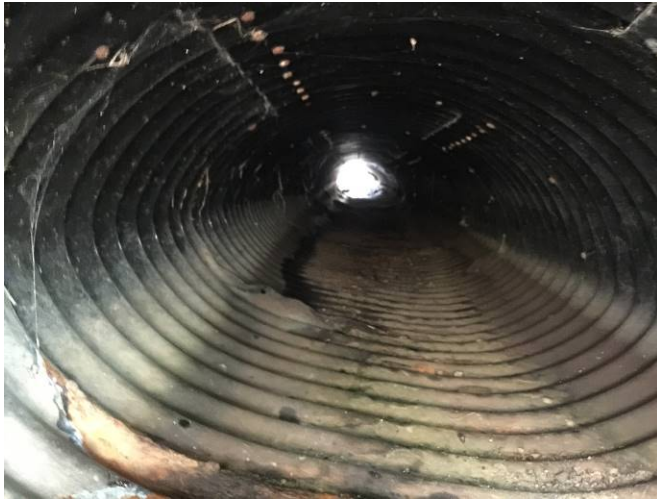
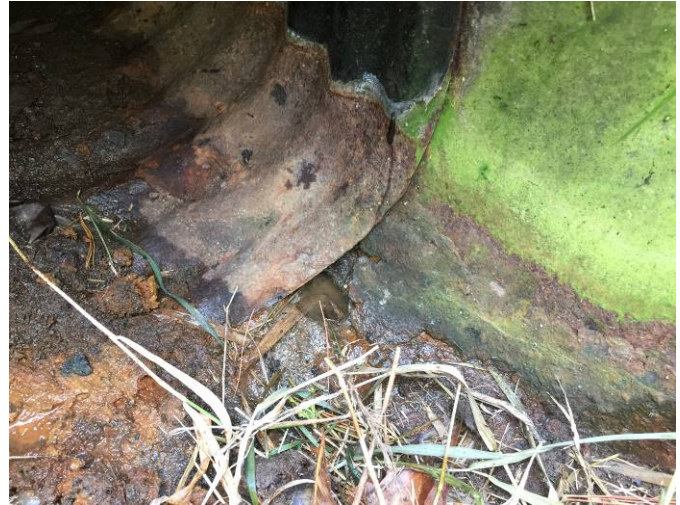
Location #9 at mile post 19.11 – 28” X 20” Pipe Arch Shape

Pipe Rating – Fix in project 3 (Poor – deteriorated, consider for repair or replacement). The polymer coating on the inlet end did show some delamination. The polymer coating on the remainder of the pipe was in good shape. There was a bump in the road over the culvert. This bump is believed to be from freeze thaw issues which led to the overall pipe rating.

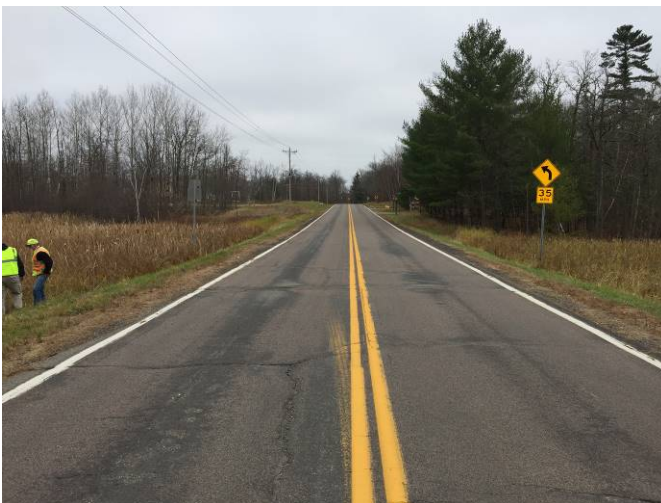
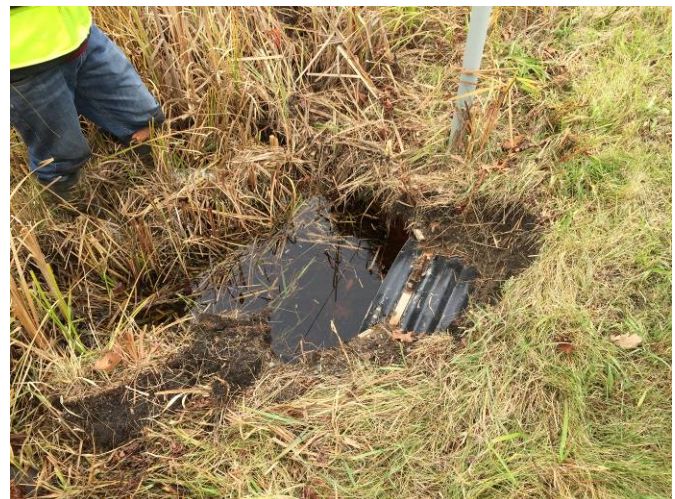
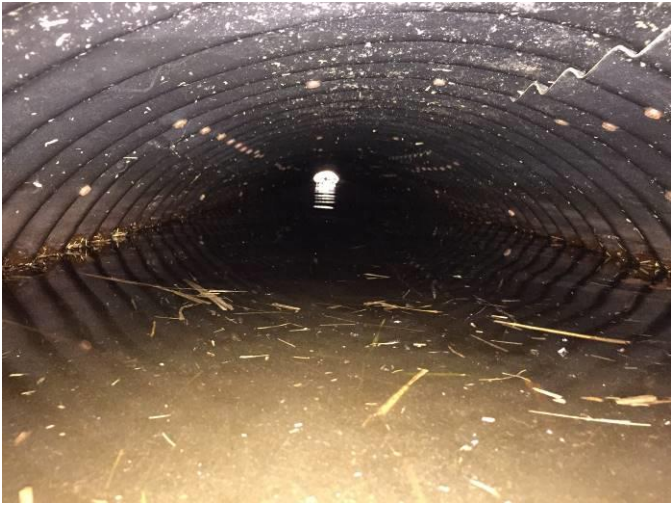
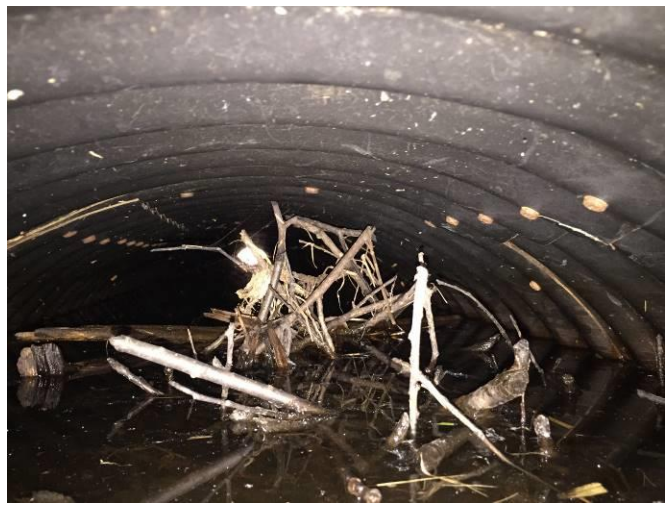
Location #10 at mile post 19.27 – 28” X 20” Pipe Arch Shape

Pipe Rating – Still Okay 2 (Fair - some wear, but structurally sound). Partially submerged with beaver dam on the outlet end. The polymer coating appeared to be in good shape in the invert when reaching through the water.

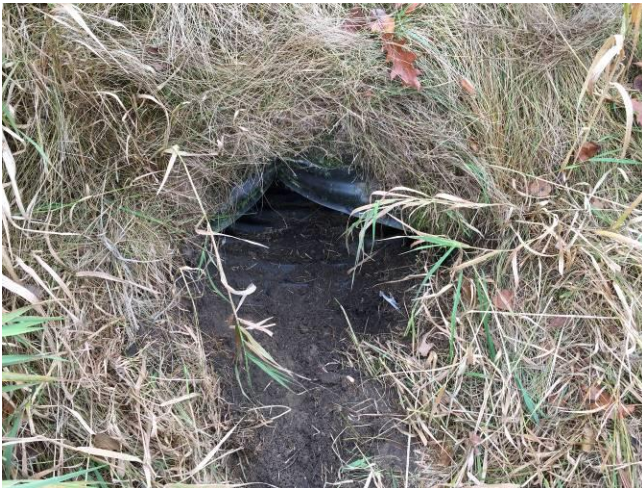
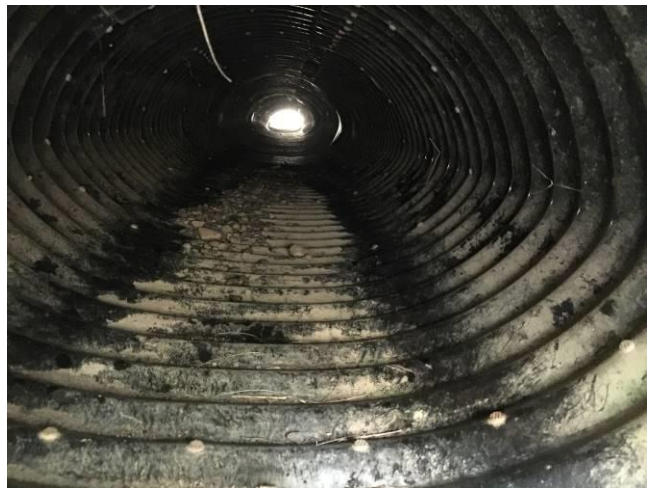
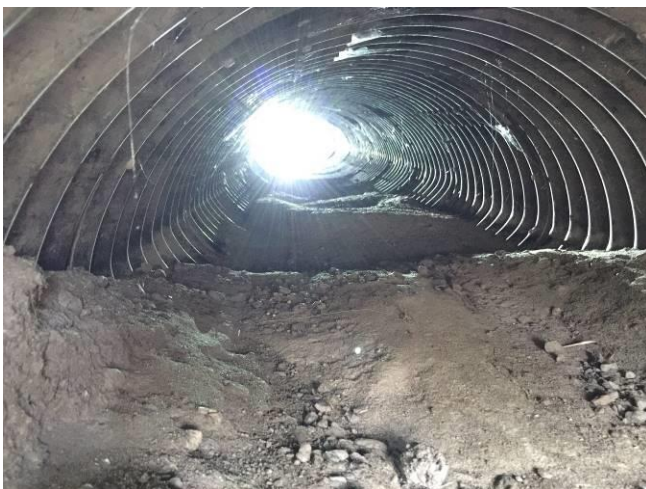
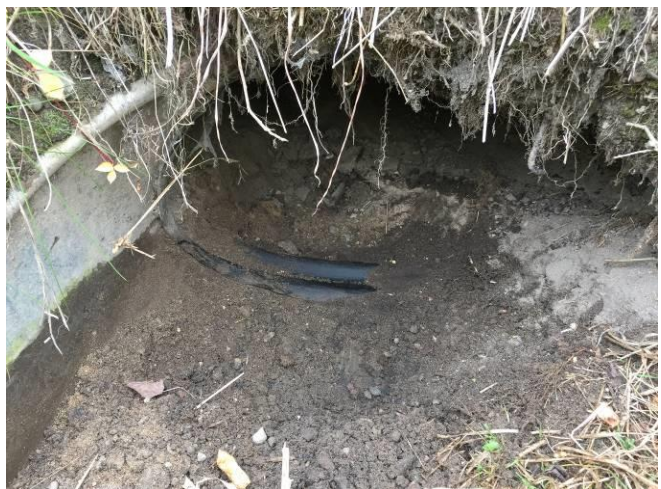
Location #11 at mile post 21.84 – 28” X 20” Pipe Arch Shape

Pipe Rating – Still Okay 2 (Fair - some wear, but structurally sound). There was sediment in the outlet end. Most of the pipe was free of sediment. The polymer coating was in good shape.

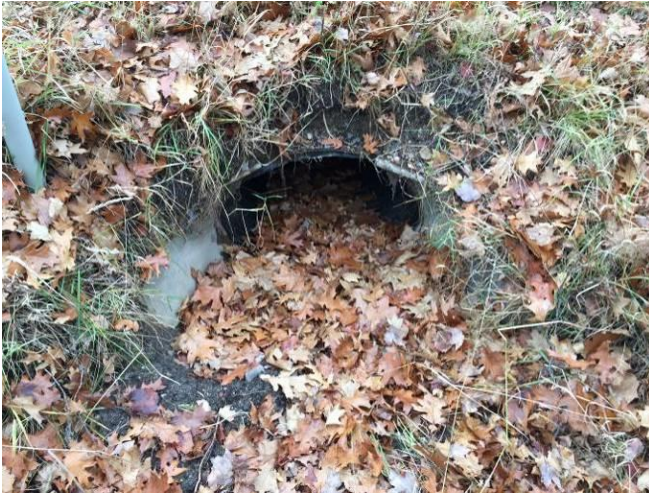
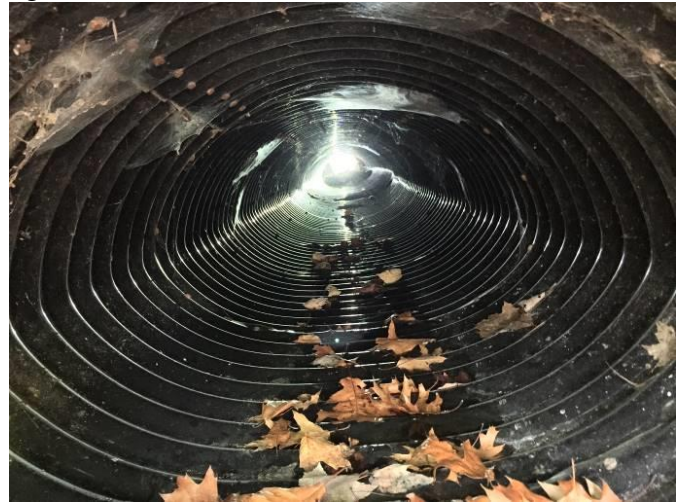
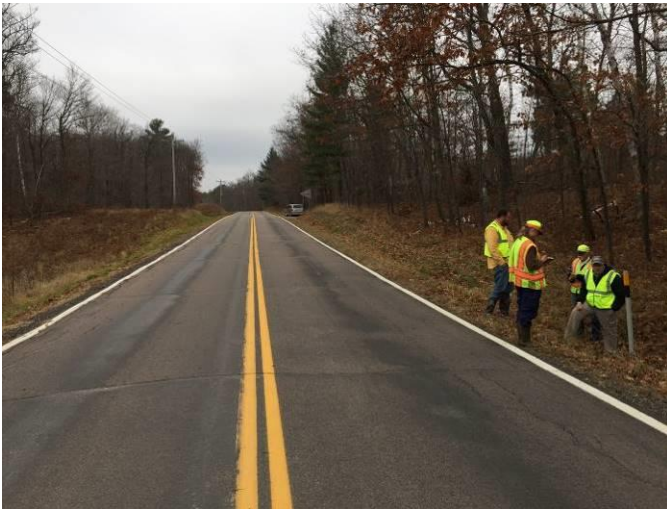
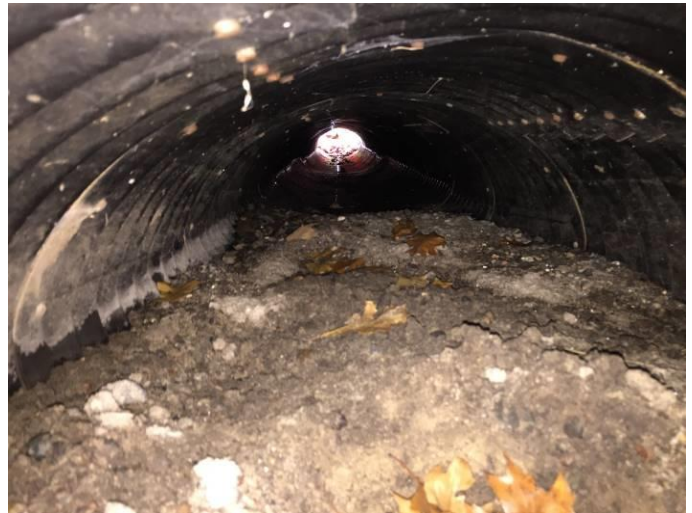
Location #12 at mile post 23.68 – 28” X 20” Pipe Arch Shape

Pipe Rating – Still Okay 2 (Fair - some wear, but structurally sound). The culvert was mostly dry with sand in the outlet and some leaves on the inlet end. The polymer coating was in good condition.

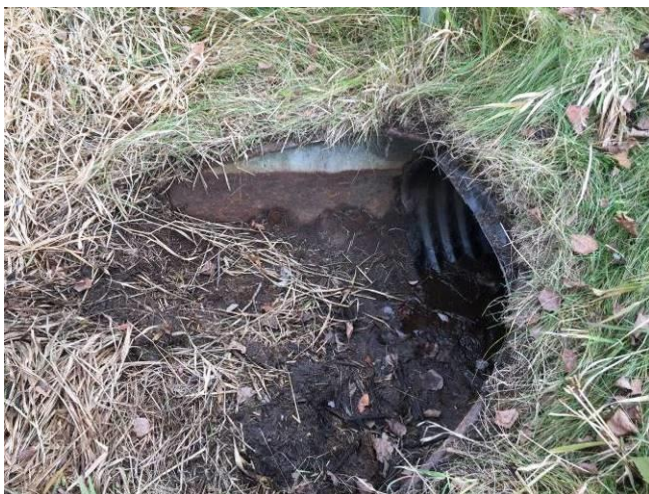
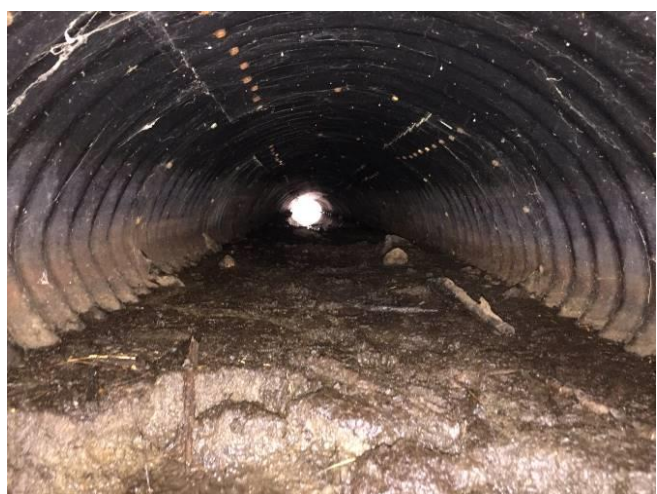
Location #13 at mile post 29.13 – 28” X 20” Pipe Arch Shape

Pipe Rating – Still Okay 2 (Fair - some wear, but structurally sound). Dry with moist sediment on outlet end. The polymer coating was in good condition. The end section shows corrosion with high water line.
