Field Performance
Evaluation of
Polymer Coated
CSP Structures in

N E W Y O R K

**NATIONAL CORRUGATED
STEEL PIPE ASSOCIATION**

March 2002

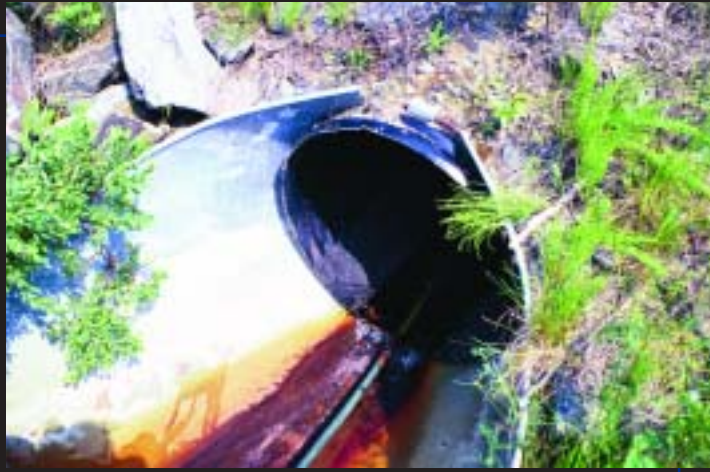
30/2206/1715

COATING CONDITION. The polymer coating was generally in excellent condition. In some locations along the cut edges, the polymer coating could be lifted from the galvanizing for approximately ¼ inch. There was no significant metal loss at these edges. At all other locations the coating was well bonded. The asphalt was well bonded to the polymer. No metal was exposed in the invert.

The galvanized end section had rust staining and some rusting steel in the invert. The staining made the extent of corrosion look slightly worse.

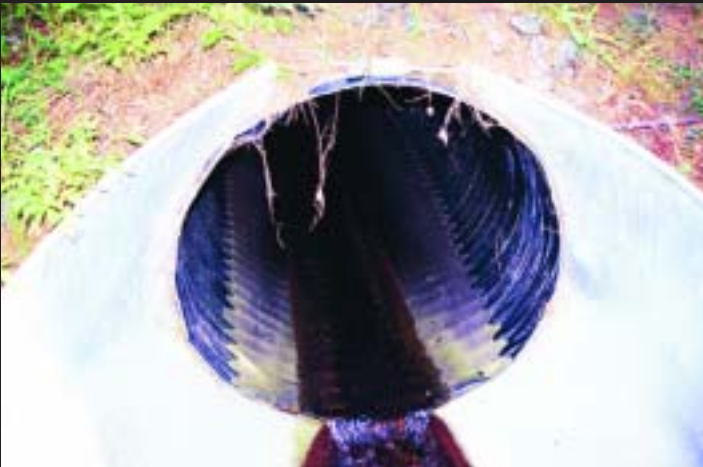
30/2206/1710

COATING CONDITION. The concrete pipe had approximately 1 inch of wear in the invert, exposing aggregate. The polymer coating was generally in excellent condition. In some locations along the cut edges, the polymer coating could be lifted from the galvanizing for approximately ¼ inch. There was no significant metal loss at these edges. At all other locations the coating was well bonded. The asphalt was well bonded to the polymer. No metal was exposed in the invert.

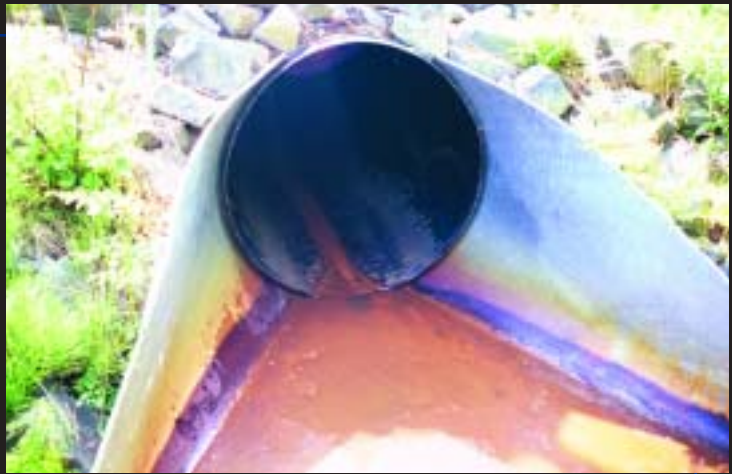
30/2206/1285

COATING CONDITION. The polymer coating had some mechanical damage, but was well adhered. The asphalt paving was well adhered inside with some mechanical damage and cracking at the exposed ends. One of the cut ends in the pipe interior has a few square inches of delamination from the cut edge in the invert.

As a comparison, the galvanized bands were severely corroded in the invert with some perforation, especially around the water line. The galvanized end sections were both rusted in the invert; the inlet (west) end was perforated in some locations.

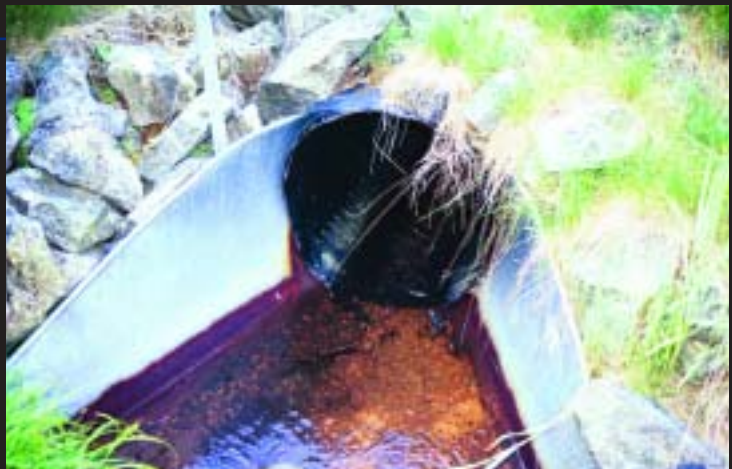
30/2206/1286

COATING CONDITION. The polymer coating was generally in excellent condition. In some locations along the cut edges, the polymer coating could be lifted from the galvanizing for approximately ¼ inch. There was no significant metal loss at these edges. At all other locations the coating was well bonded. The asphalt was cracked at the ends of the paved invert, but was well bonded to the polymer. No metal was exposed in the invert.

The galvanized end sections showed corrosion in the invert.
