Field Performance
Evaluation of
Polymer Coated
CSP Structures in

W I S C O N S I N

**NATIONAL CORRUGATED
STEEL PIPE ASSOCIATION**

March 2002

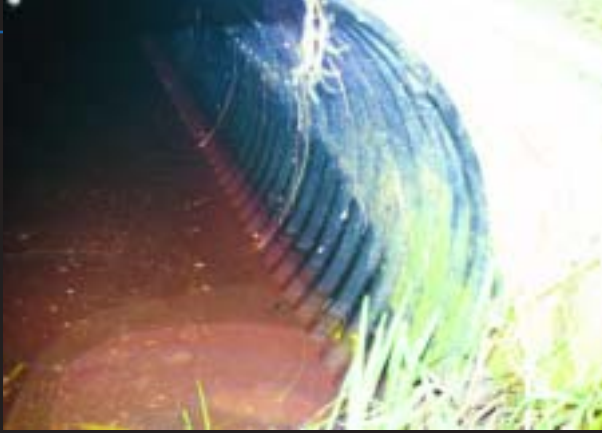
^ Polymer Coated

Polymer Coated. One of the test pipes was polymer coated and riveted construction. The pipe had several inches of standing water and approximately one inch of silt at the time of the inspection. The polymer coating was well adhered and pliable. The coating thickness was 12 mils (polymer plus galvanized) both internal and external. Approximately ¼ inch of polymer could be lifted at some locations along the edge of pipe. Near the rivets, no polymer delamination was evident.

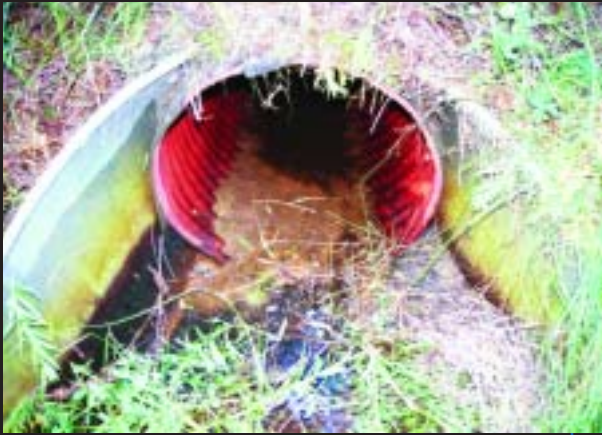
^ Epoxy Coated

Epoxy Coated. One pipe at this site was spiral weld construction with an epoxy coating applied. The pipe had a few inches of heavily silted standing water at the time of the inspection. The coating thickness was measured between 22 to 26 mils. From the east end the coating was observed to be in good condition, including over the welds. The epoxy could only be chipped off of ¼ inch at the cut edge. The west end of the pipe showed coating damage, with the bottom 270 degrees of coating missing. Where the coating is missing, there is active corrosion but no perforation.

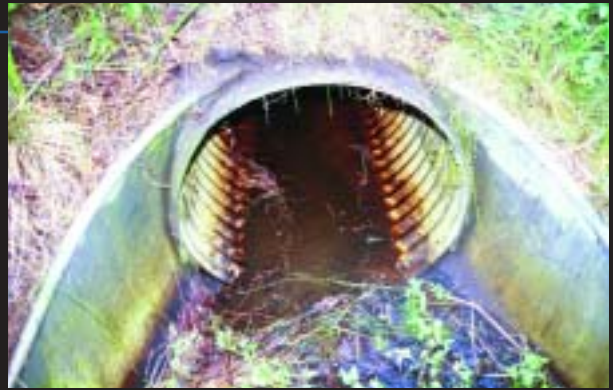
^ Aluminum

Aluminum. One pipe was constructed of riveted aluminum. The pipe had several inches of standing water and approximately one inch of silt at the time of the inspection. Staining and very light pitting (not practicably measurable in the field) was present on pipe interior, especially in the invert.

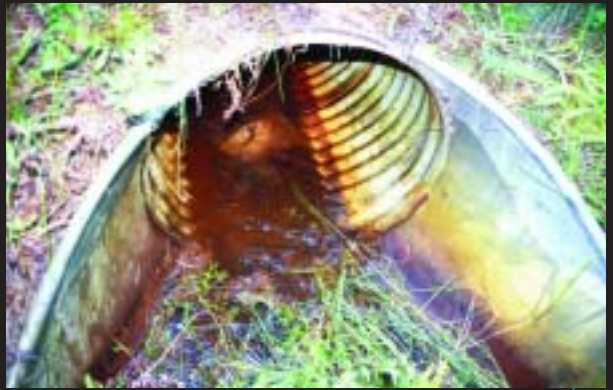
^ Aluminum Coated Type 2

Aluminum Coated Type 2. One pipe at this location was helically fabricated from aluminum coated material with a galvanized end section. There was several inches of water saturated mud in the invert, possibly the cause of the higher observed water pH. The lockseam had some minor corrosion, otherwise the pipe appeared to be in good condition.

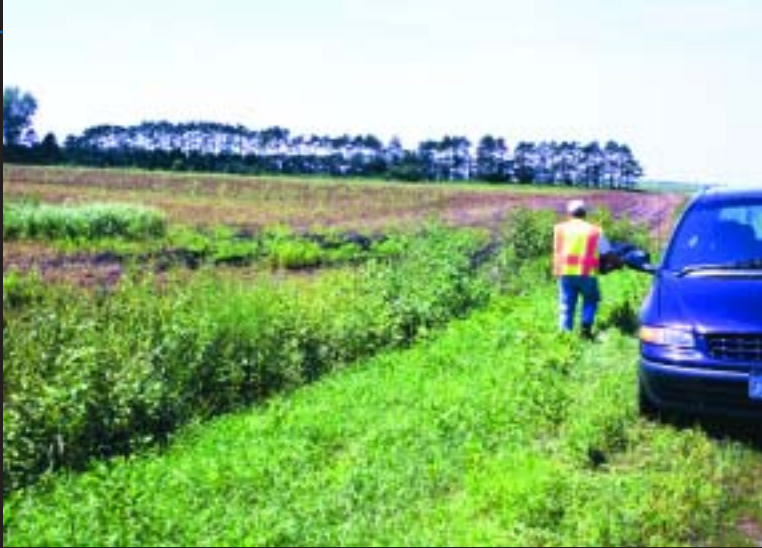
^ Farm Drainage

At this location there was one, 30-inch diameter polymer coated pipe. The pipe was installed in 1974 and was 27 years old at the time of our inspection. The pipe carried agricultural runoff from a farm on the south end to a small, wooded pond on the north end of the pipe. Thickness measurements revealed that the polymer coating was 10 mils inside and 3 mils outside. On the interior of the southern exposed end, a triangle of polymer coating at the crown tapering back to the exterior cut edge of the pipe was delaminated (approximately 2 square feet). This area was slightly smaller than the exposed end. The polymer was tightly adhered at the edges of the delaminated area. There was no corrosion under the film. The polymer on the remainder of the pipe was well adhered.

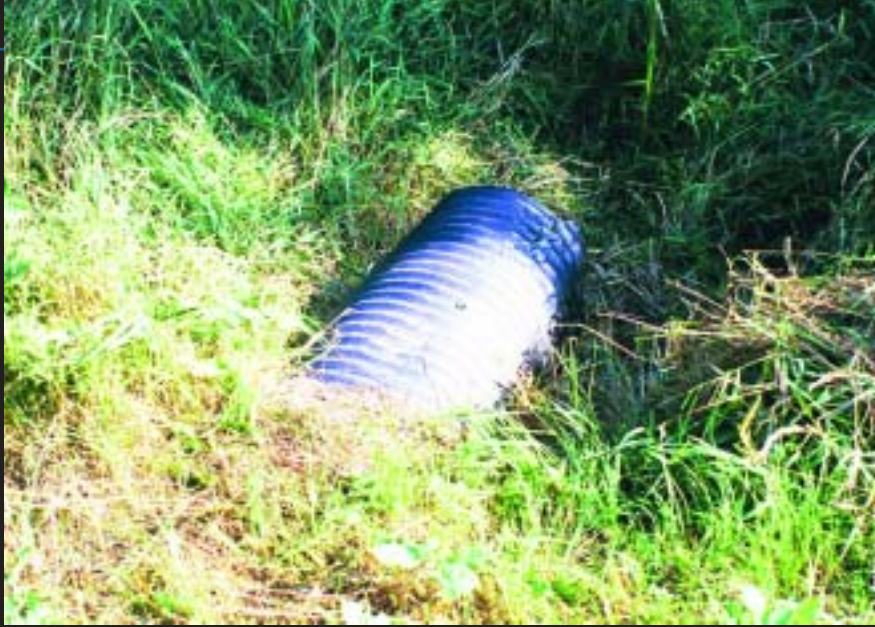
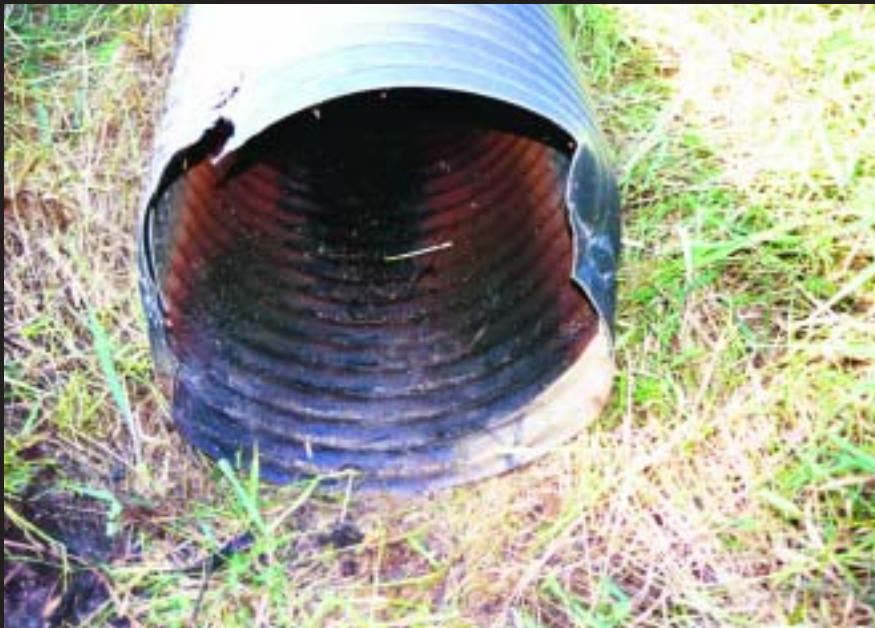
Town Hall Road. This 30-inch diameter polymer coated pipe was installed in 1974. It was approximately 27 years old at the time of the inspection. It is riveted construction installed without end sections. Thickness measurements revealed that the polymer coating was 10 mils inside and 3 mils outside. Approximately 4 feet of pipe was exposed on either end and subjected to mechanical damage. The polymer coating was tightly adherent, even at the locations of mechanical damage. Negligible lifting of the polymer was possible when picked with a knife.

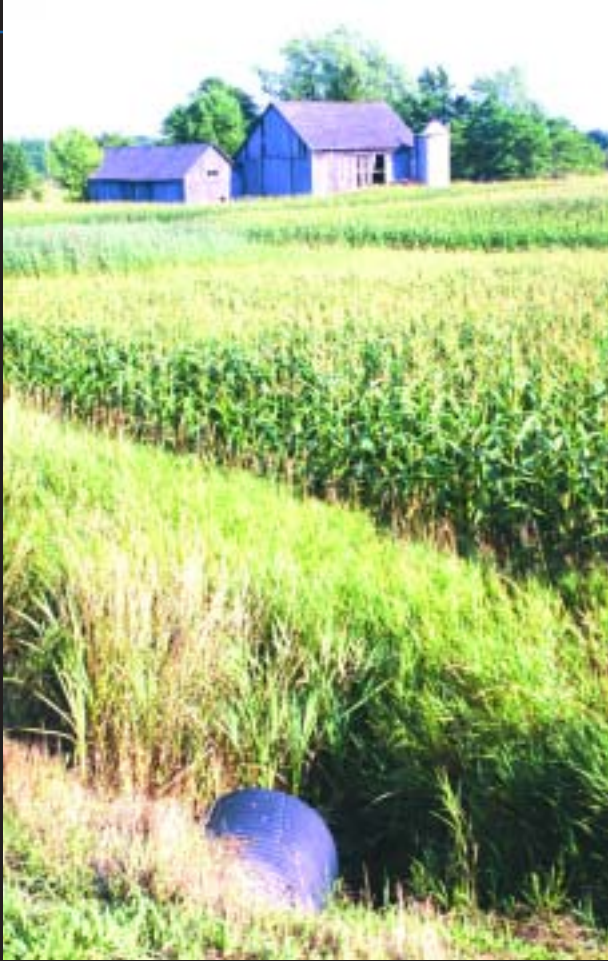
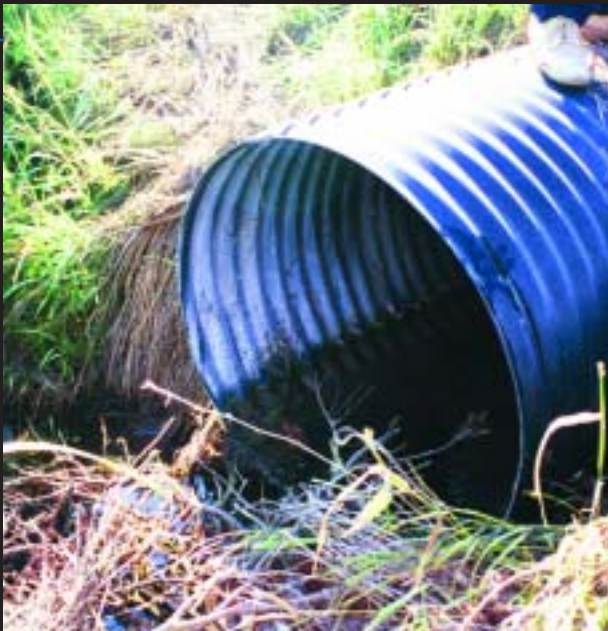
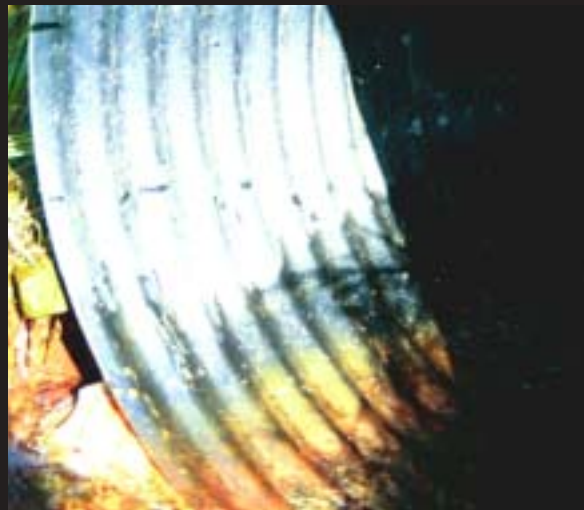
Cherneyville Road. This 36-inch diameter pipe is under a two-lane road adjacent to a cheese factory and was installed in 1977. Polymer thickness was confirmed to be nominally 10 mils inside and out. The invert was in good condition with a white, lime like material covering the invert and up the sides on the outlet end. At the inlet end, approximately $\frac{3}{4}$ inch of polymer could be lifted from the cut edge. The polymer was tightly adherent throughout the remainder of the pipe, including the outlet cut edge.

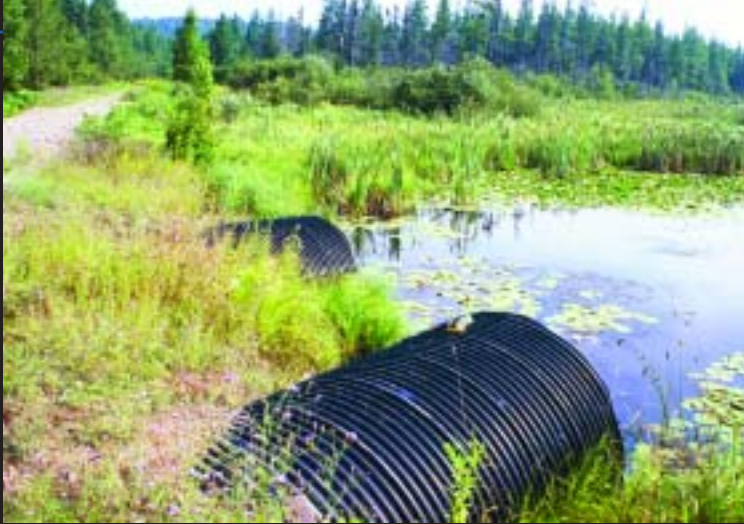
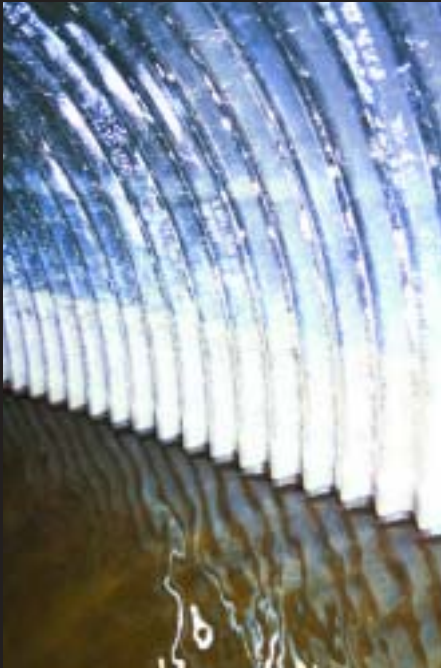
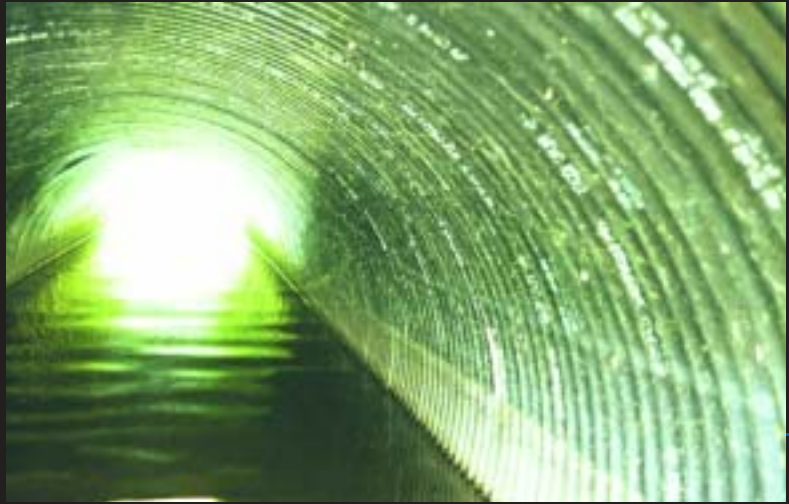
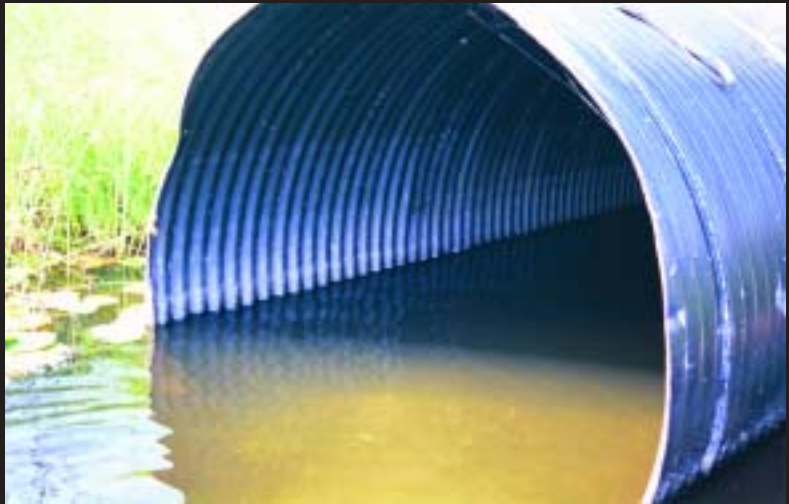
This site has two, 72-inch diameter polymer coated pipes adjacent to each other. The pipes appear to have been installed in 1984, making them 17 years old at the time of the inspection. The pipes serve as equalizers between two swampy areas underneath an abandon railroad. There were no joints in either pipe. The polymer was well bonded and in good shape over the entire length of the pipe. There was minimal polymer peeling at the cut edge—maximum of 1/8 inch underwater, 1/8 inch in “dry” areas.
