Instant Bridge – Ontario Highway 28 at Bow Lake

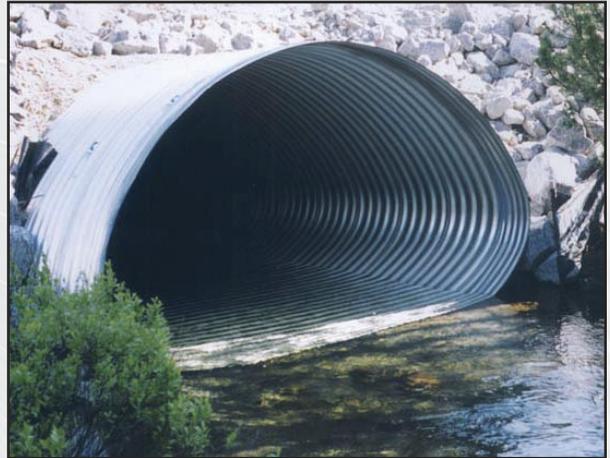
**CORRUGATED STEEL PIPE ARCH
3650MM X 2280MM, 3.5MM ALUMINIZED TYPE 2 STEEL**

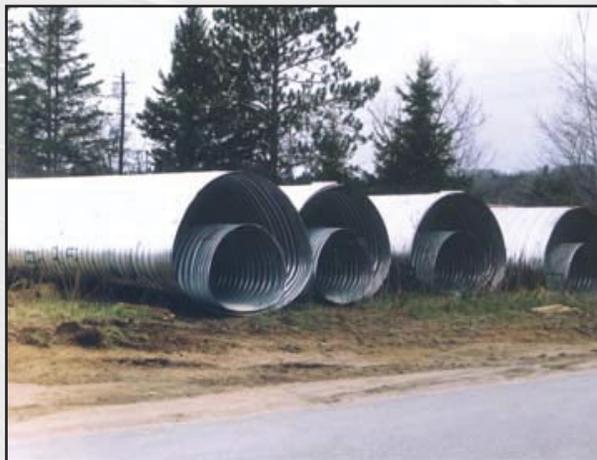
ON SITE READY FOR INSTALLATION WHILE MAINTENANCE PIPES WERE NESTED INSIDE AND TOOK A FREE RIDE

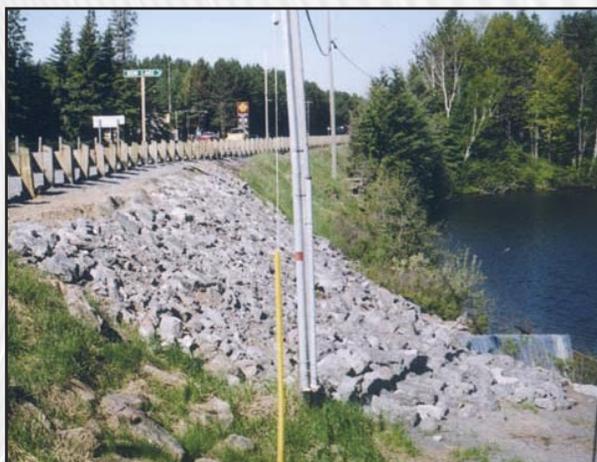
BOW LAKE CULVERT TWENTY THREE DAYS OLD
