## Out of Sight, Not Out of Mind – Heart Lake Storm Sewer Reline

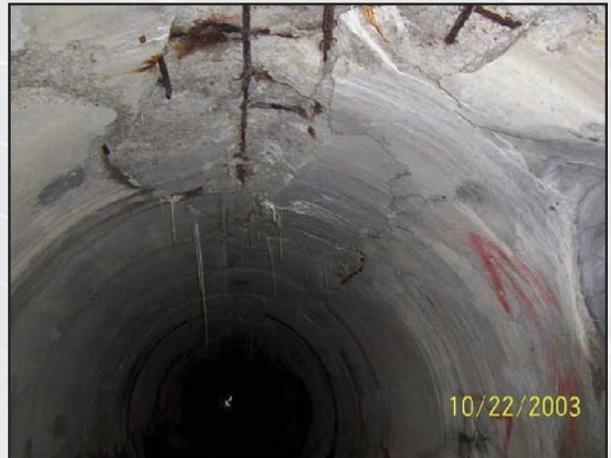
At the intersection of HWY 401, HWY 410 and HWY 403 some 321,000 vehicles pass every day. Under layers of intertwined bridge structures is the Heart Lake Storm Sewer. Built in 1980 this 3050 mm diameter reinforced concrete sewer was showing signs of serious deterioration. Large cracks were evident, the result of the rigid sewers inability to accommodate extreme pressures but relatively minor movement of the expanding shale bedrock. Corroded reinforcing steel was exposed at the top of the pipe. It was apparent that road salt was making its way into the concrete walls.

CRACKED AND CORRODED RIGID SEWER PIPE

The decision was made to reline the existing sewer and extend its life. The Consultant, Morrison Hershfield was charged with finding a system that would accommodate the expected loads and up to 90 mm of future shale bedrock expansion. The liner would also have to meet all of the physical and hydraulic constraints of the project.

A variety of liners were considered. In the end Corrugated Steel Pipe with a 2850mm inside diameter was selected. A 125 x 25 mm corrugation in 4.2mm thickness met both the structural and hydraulic requirements. As a flexible pipe CSP evenly distributes load to the surrounding backfill allowing it to safely support enormous loads.

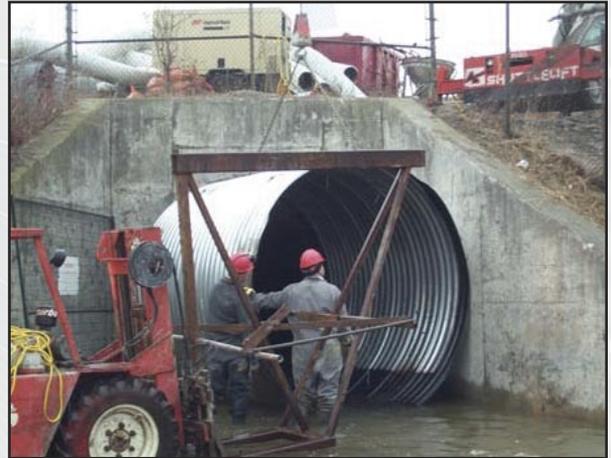
The contractor, Underground Services, developed a special frame to carry the CSP liner sections into the sewer using a small fork lift truck. An innovative de-watering scheme proved to be cost efficient and highly effective, accelerating the progress of the project.

FORK LIFT WITH CARRYING FRAME

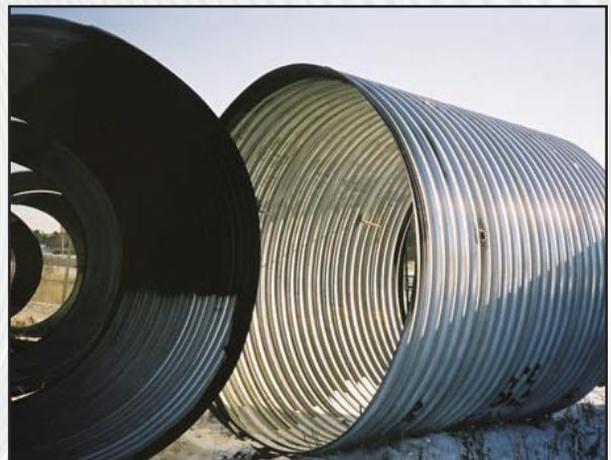
Each section of pipe had screw jacks fitted at the manufacturer's plant. These were required for accurate adjustment of line and grade prior to blocking and installation of internal coupling bands. Grout fittings in the liner walls allowed for controlled pumping of grout into the cavity between the liner and host pipe.

CSP WITH SCREW JACKS AND GROUT PLUGS
