## Out of Sight, Not Out of Mind – Heart Lake Storm Sewer Reline

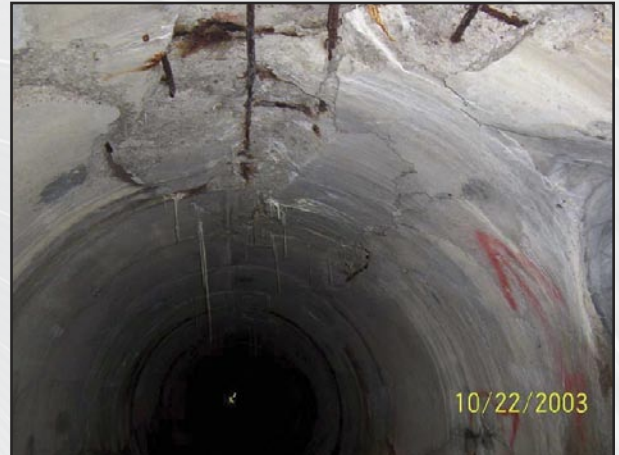
At the intersection of HWY 401, HWY 410 and HWY 403 some 321,000 vehicles pass every day. Under layers of intertwined bridge structures is the Heart Lake Storm Sewer. Built in 1980 this 3050 mm diameter reinforced concrete sewer was showing signs of serious deterioration. Large cracks were evident, the result of the rigid sewers inability to accommodate extreme pressures but relatively minor movement of the expanding shale bedrock. Corroded reinforcing steel was exposed at the top of the pipe. It was apparent that road salt was making its way into the concrete walls.

CRACKED AND CORRODED RIGID SEWER PIPE

The decision was made to reline the existing sewer and extend its life. The Consultant, Morrison Hershfield was charged with finding a system that would accommodate the expected loads and up to 90 mm of future shale bedrock expansion. The liner would also have to meet all of the physical and hydraulic constraints of the project.

A variety of liners were considered. In the end Corrugated Steel Pipe with a 2850mm inside diameter was selected. A 125 x 25 mm corrugation in 4.2mm thickness met both the structural and hydraulic requirements. As a flexible pipe CSP evenly distributes load to the surrounding backfill allowing it to safely support enormous loads.

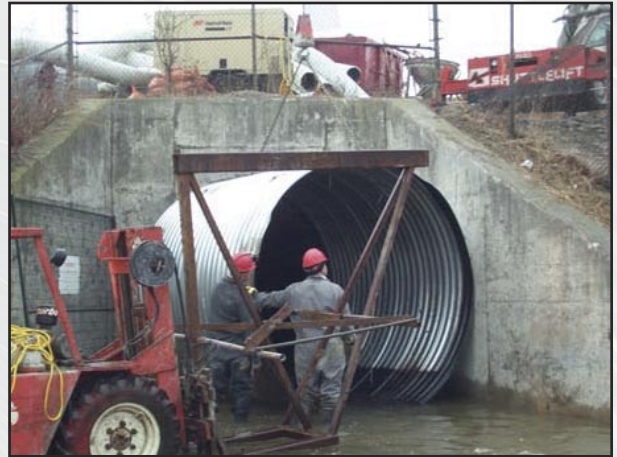
**FORK LIFT WITH CARRYING FRAME**

The contractor, Underground Services, developed a special frame to carry the CSP liner sections into the sewer using a small fork lift truck. An innovative de-watering scheme proved to be cost efficient and highly effective, accelerating the progress of the project.

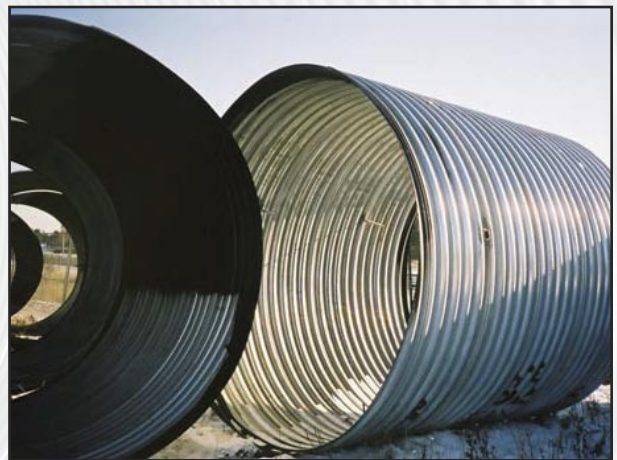
**CSP WITH SCREW JACKS AND GROUT PLUGS**

Each section of pipe had screw jacks fitted at the manufacturer's plant. These were required for accurate adjustment of line and grade prior to blocking and installation of internal coupling bands. Grout fittings in the liner walls allowed for controlled pumping of grout into the cavity between the liner and host pipe.
