Field Repair of Polymer Coatings

The purpose of this Technical Bulletin is to define best practices for field repair of polymer laminated CSP and polymer coated SPCSP during construction or in-service.

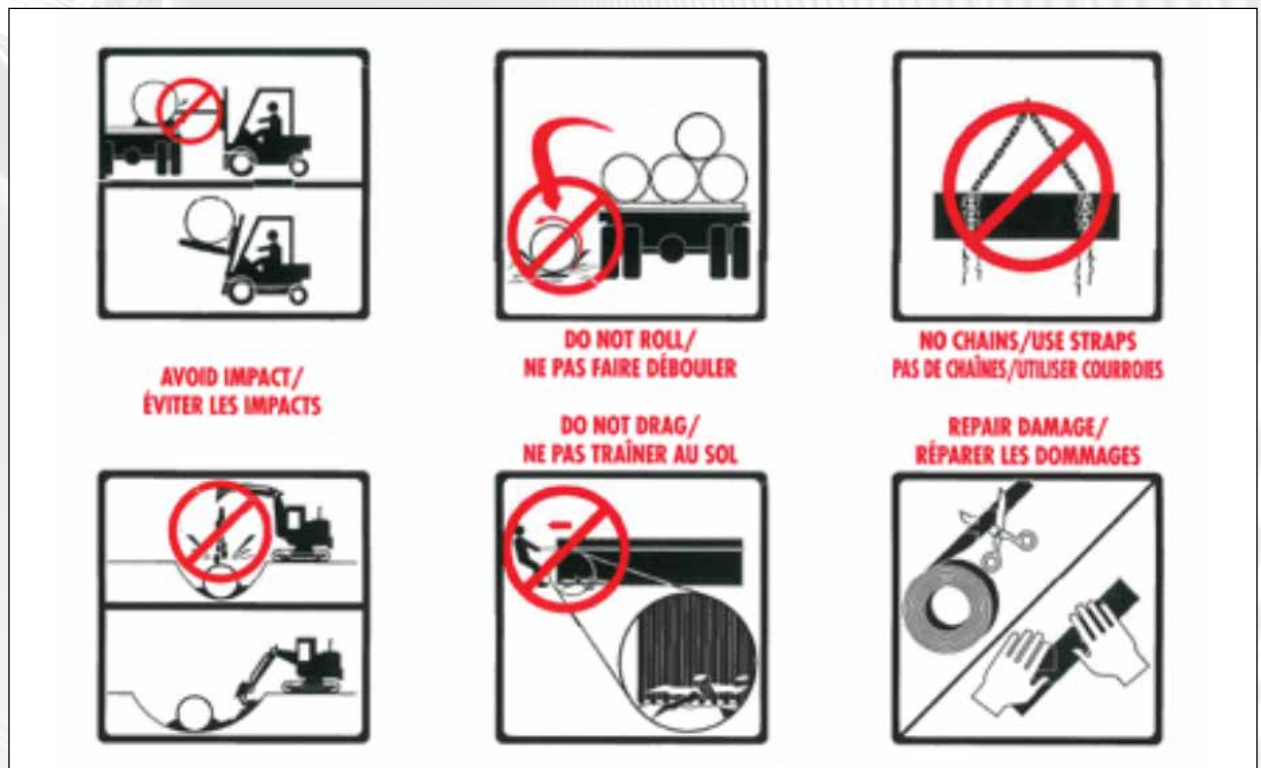
Handling polymer coated steel / Manutention des TTOG à strates de polymère
