Evaluation of Bolt Coatings

(File #16-011)

**Infrastructure
Materials Service**

December 2016

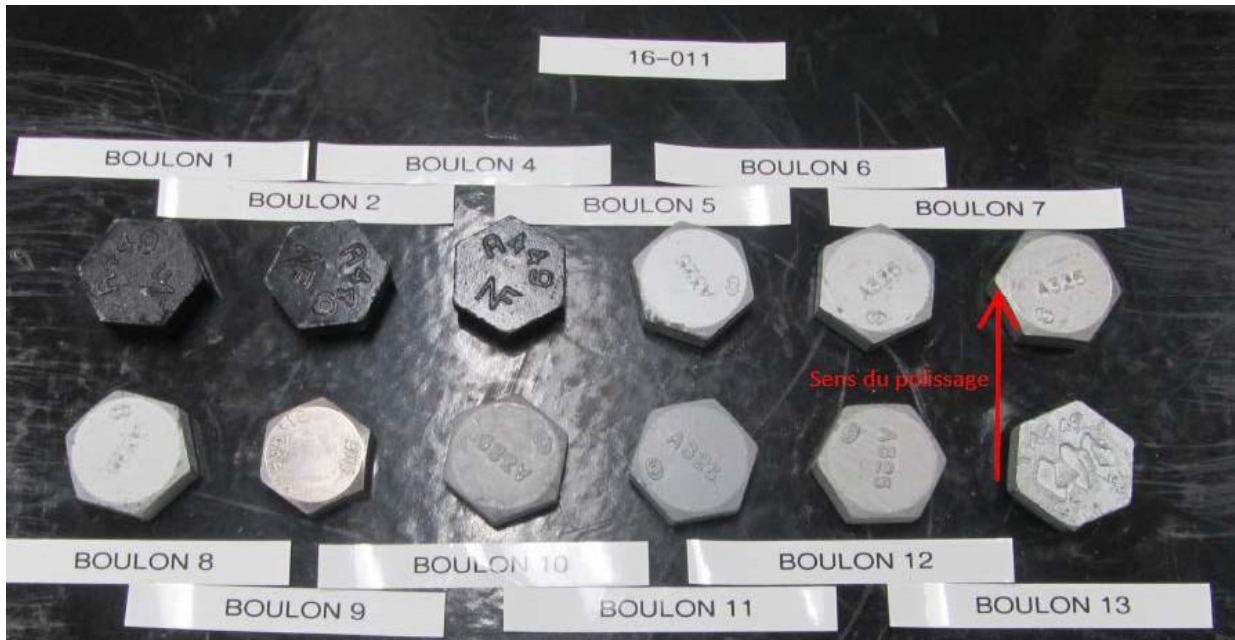
Photo no1: Arrangement of samples for the abrasion test

For the abrasion test in accordance with internal standard LC21-102, we used an Elite Technology type polisher composed of a closed chamber, an abrasive feeding electrical installation with an adjustable flow rate and a pressure compressor, and water supply. The abrasive used is Ottawa sand (chosen according to ASTM C778).

The bolts and the nuts are placed on a steel support and exposed with the abrasive blast front part (see Figure 1, Appendix 1) applied with a pressure of 10,000 kpa, a flow rate of 541 g / min during 7 stages at a duration of 43 min 20 s / 20 cycles.

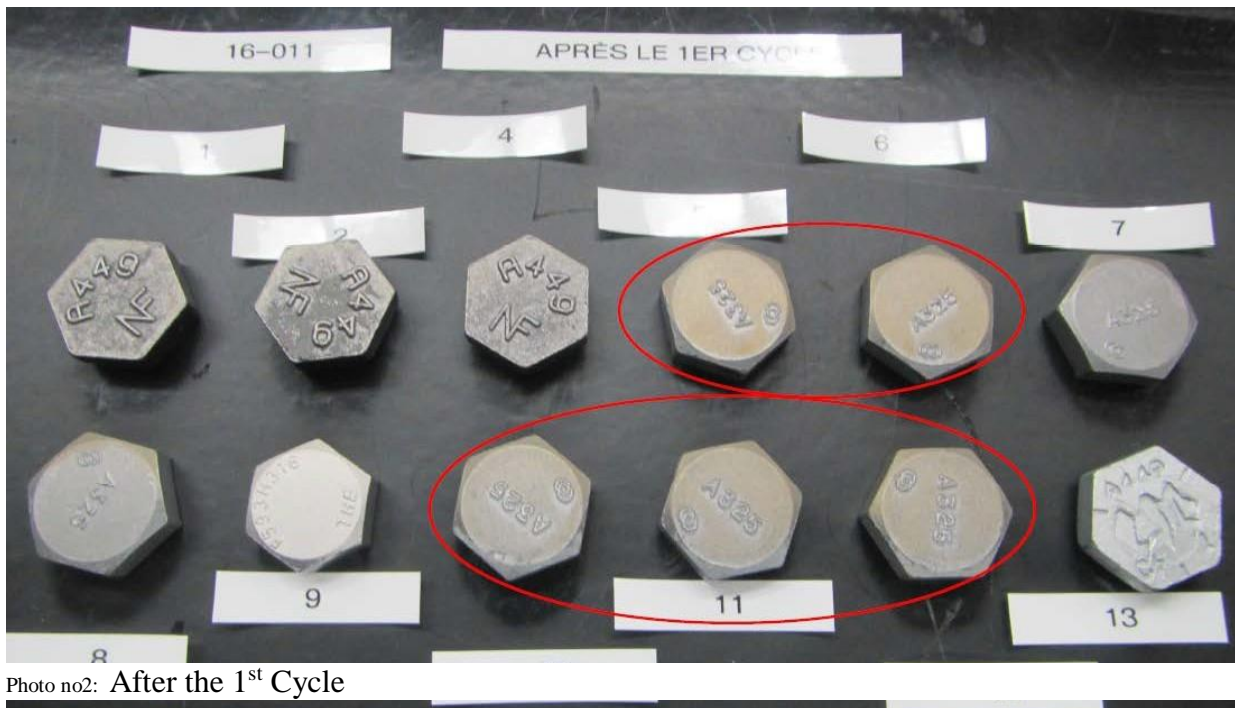
Photo no2: After the 1st Cycle

At the start and after each test, we visually inspected samples and measured the thickness of the coatings. For each sample, we marked the time of the total loss of the coating (recorded by measurement). The total loss of the coating is also visualized and corresponds to the time of occurrence of corrosion over the entire surface of each sample (see Photos 2 to 8, Appendix 1).

- samples **5,6,10,11,12** which lost their coating and rusted after the first cycle
- samples **1,2,4,7,8** which showed some loss of coating after the first cycle and total loss after the 2nd cycle when rust was apparent.

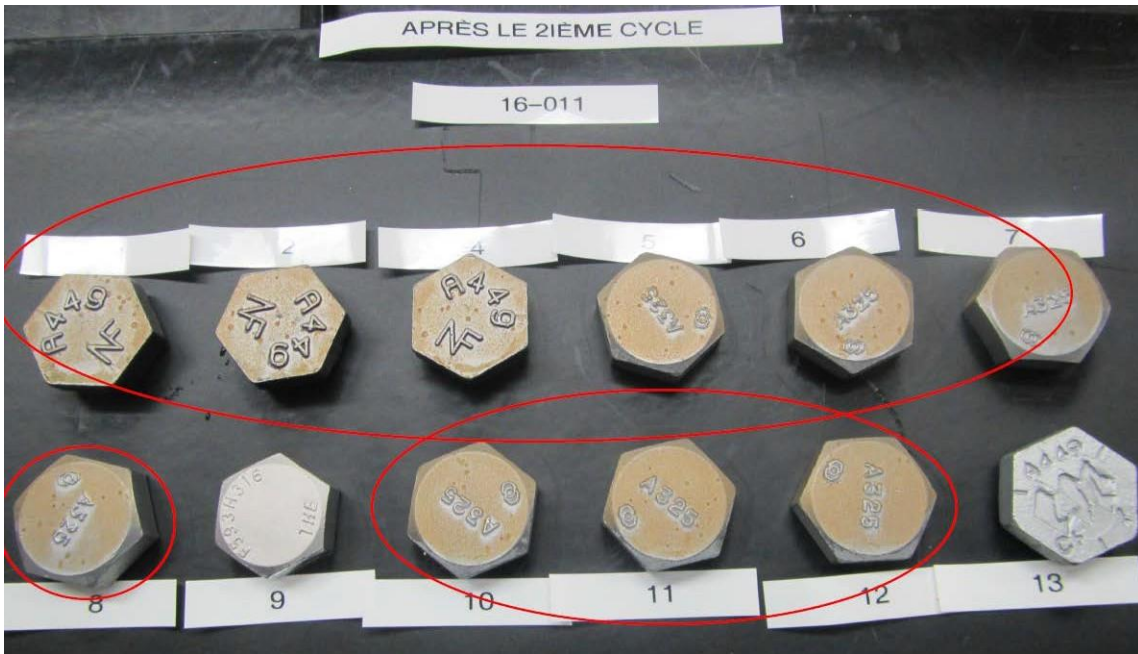
Photo no3: After the 2nd Cycle

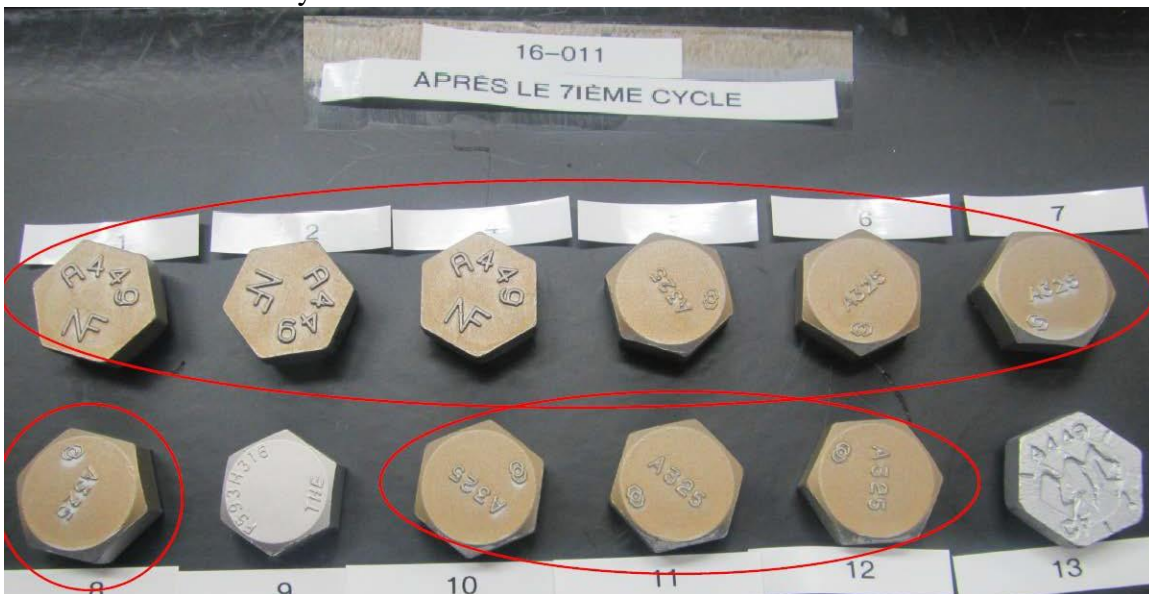
Photo no4: After the 7th Cycle

The most abrasion-resistant was sample 13, the Hot Dip Galvanized bolt. At the end of the 7th cycle, the coating was still 85 µm thick

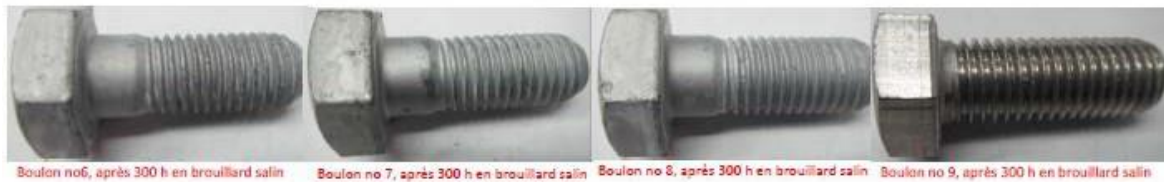
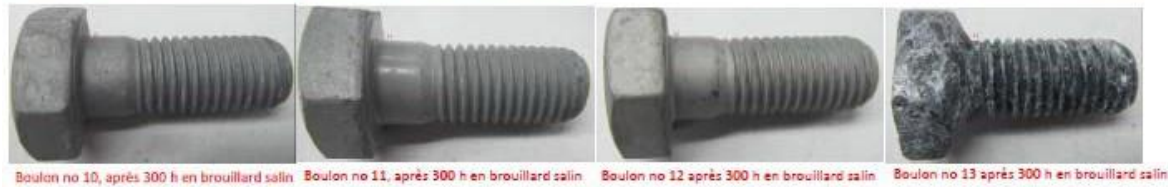
Photo no1: After 300 hours of Salt Spray Test

Periodic observations on the condition of the coating are carried out every 250 hours or so, for a total of 4180 hours. The plates were removed at these intervals, rinsed and cleaned with a nylon brush. Here are the results:

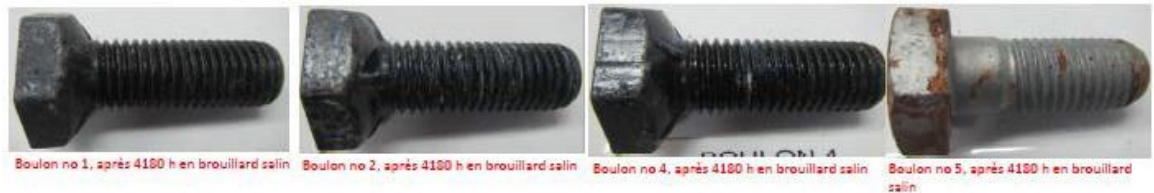
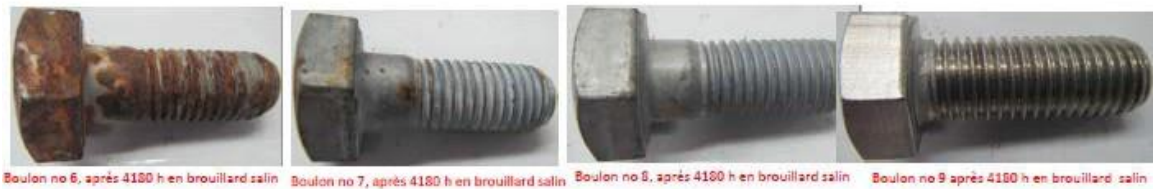
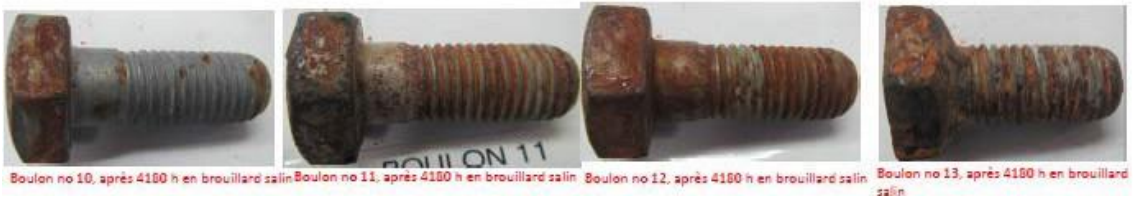
Photo no 2: After 4,180 hours of Salt Spray Test

Number 13 (HDG) which gradually corroded between 830 and 4,180 hours. At 2,050 hours, it was entirely corroded. It is closely followed by **number 6 (Geomet T 321)**, **number 11 (Magni Coated Bolts - BO6J+P126L)** and **number 12 (Magni Coated Bolts - BO6J + B18)**. These bolts were corroded progressively between 1,000 and 2,840 hours. After 4,200 hours, these bolts show 90% corrosion of the total coating.

Sample **number 7 (Dacromet -ASTM F1136)**, which started corroding at 3,375 hours in salt spray. At 4,180 hours, the bolt was corroded at 20% of its surface.

Samples **number 5 (Geomet 321 - ASTM F1136)** and **number 10 (Magni Coated Bolts - 2 X B18 RE)** corroded between 2,840-3,840 hours. At 4,180 hours in salt spray, these samples were corroded at 40% of their surface.

Good corrosion resistance is attributed to sample **number 8 (Dacromet Plus)** where the coating is etched at 3,840 hours and the bolt begins with isolated corrosion points ($\text{diam} \leq 05 \text{ mm}$) at the end of the test (4,200 hours).

The **best resistance** to corrosion is attributed to samples **number 1 (Phos – Leland)**, **number 2 (Undip AP – Leland)** and **number 4 (Undip (A) – Leland)**. The coating demonstrated superior resistance to corrosion and the bolts show zero corrosion at the end of the test (4,180 hours).

The visual appearance of sample **number 9, the stainless steel** bolt without covering remained very good and the surface remained shiny.
