CROSSING REPLACEMENT DESIGN ON DERICKSON ROAD AT TRIBUTARY 3 OF TWO JOHN CREEK

CIEN 240

December 10th, 2015

TRIBUTARY 3 CROSSING DERICKSON ROAD WASHOUT

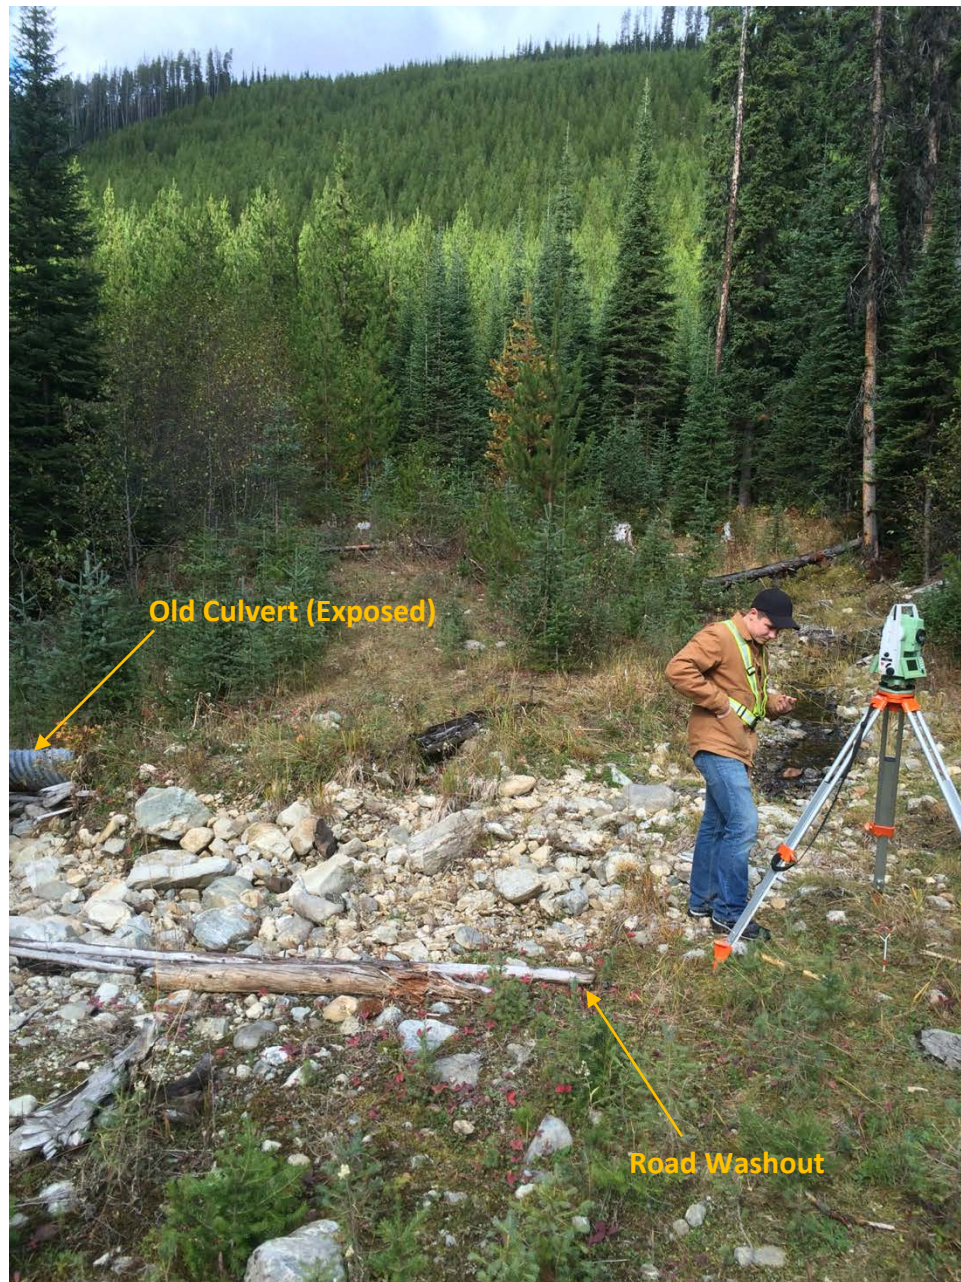
Fig. 2 – Derickson Rd. Washout at Tributary 3. (Taken by Eric)

From a site visit, it was determined that the washout of Derickson Rd. occurred due to the original culvert being undersized and installed at the wrong angle to accommodate high peak flows. The poor design of the existing culvert allowed the

extreme flow of water to bypass the existing culvert and erode the road to the South of the culvert as shown in Fig. 2.
