Culvert Inlet Sizing Alert – Mountain Pine Beetle Epidemic

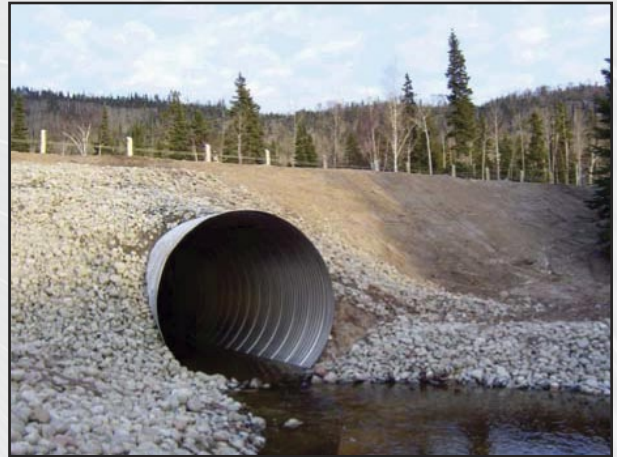
EMERGENCY REPLACEMENT FLOODED BOX CULVERT WITH CSP

picked up a heavy debris load and washed out several bridges and a 1.2 metre span timber box culvert that had performed adequately for fifty years. The Trans Canada Highway was closed for a few days while a much larger 3000mm diameter CSP was fabricated in extra long lengths, delivered to site under police escort and installed. Selecting Larger Culverts is part of the solution as they are less likely to become blocked with sediment and debris and will carry the higher volumes due to increased peak flows. A designer must anticipate changes to runoff patterns and volumes in the future.
