Analysis and Case Study of Polymer Coatings as an Alternative to Galvanized and Bituminous Coated Steel Liner Plate Supports in Railroad Tunnels and other Railroad Crossing Tunnels.

Jack Mulvoy, P.E.

Renn Oler

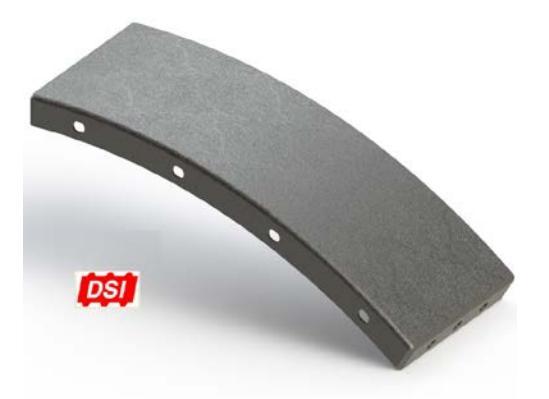
This paper addresses the use of four flange liner plates as they are the only liner plates suitable for use in both hand mining and machine mining of tunnels without alteration and addition of structural stiffening elements. Figure 1 shows the general shape of a four flange liner plate and the connecting bolt pattern optimizing its use from inside any tunnel.

Figure 1: Typical Four Flange Liner Plate

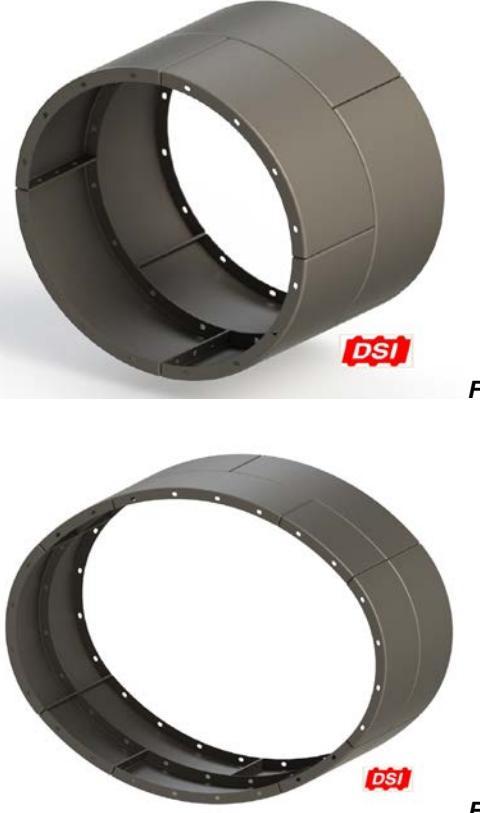
As the radius is variable, the shape of liner plate tunnels can vary from circular, elliptical, to horseshoe types as shown in Figures 2a, 2b and 2c respectively.

Figure 2a: Assembled Circular Liner Plate Tunnel

Figure 2b: Assembled Elliptical Liner Plate Tunnel

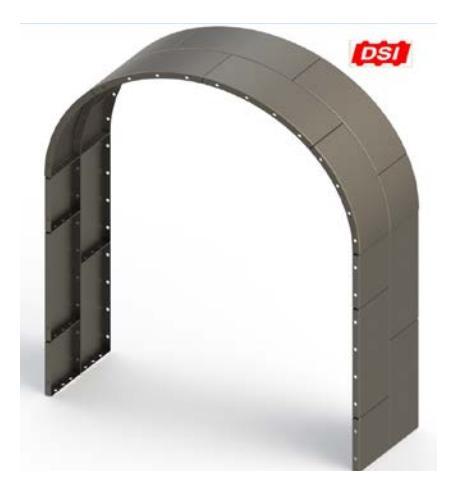
Figure 2c: Assembled Horseshoe Liner Plate Tunnel

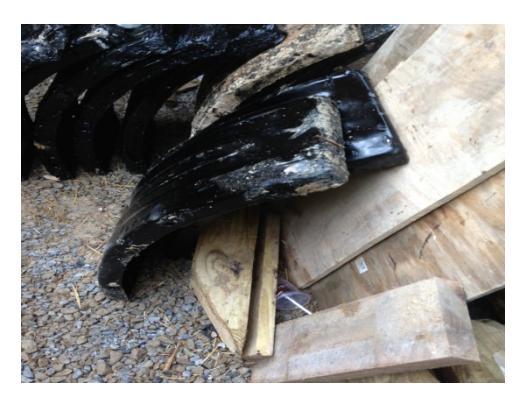
Figure 3 shows the physical makeup of a galvanized and bituminous coated four flange liner plate. The bitumen creates a less than desirable working element which is difficult to handle and install in any advancing tunnel. Additionally, as shown, the bitumen attracts and retains deleterious materials including the dirt and debris visible.

Figure 3: Typical Galvanized and Bituminous Coated Liner Plate

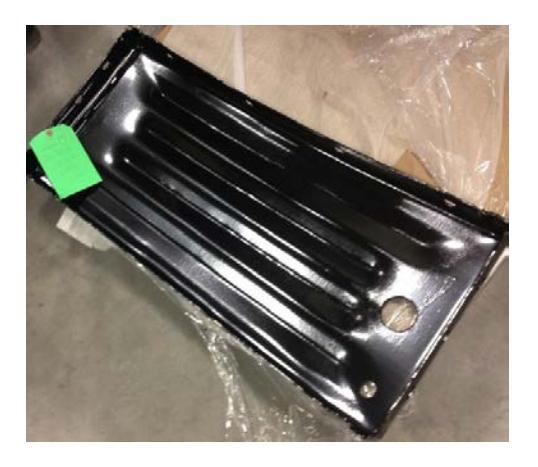
Figure 4 shows the appearance after a typical four flange liner plate is polymer coated.

Figure 4: Typical Polymer Coated Liner Plate

Four flange liner plates with polymer coatings applied only increase the nominal liner plate weight by less than one pound. Additionally, polymer coated liner plates do not attach to or retain deleterious materials such as dirt and debris during handling and installation. In nominal ground conditions, polymer coated liner plates are expected to provide 75 years of service life.
