12.21.10 BEAVERLY, BC CANADA

## **Fire Fighting From a Full Tank**

90,000 LITRE FIRE FIGHTING TANK

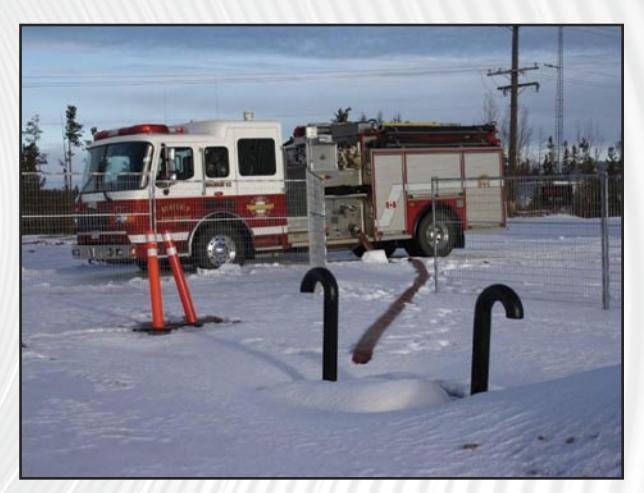
PUMP TRUCK FILLING

The polymer laminate coating on galvanized steel provides long term durability for the system and helps to maintain clear water quality. It is a requirement that the pumper trucks be tested on a regular basis. For these tests large volumes of water are drawn from the tank, into the pumper truck and then back into the tank. The water is reused without taxing the municipal treated water and storm sewer systems.
