Exceptional Durability of Galvanized CSP in Southern Manitoba

steel pipe institute

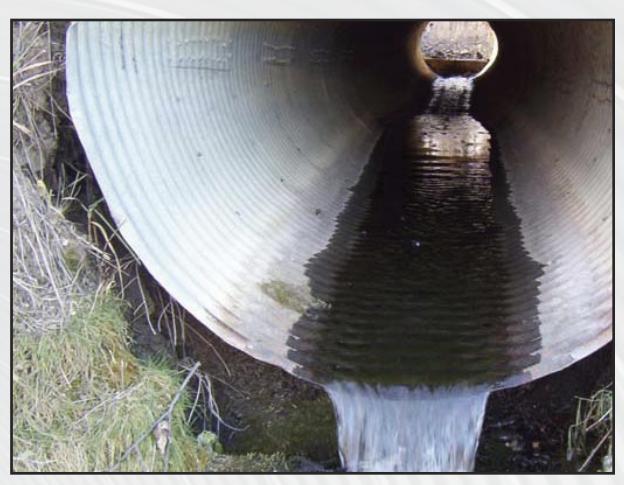
PROTECTIVE SCALE ON OLDER CULVERT

The key to the exceptional durability of CSP in Southern Manitoba is the water. Today's water is not unlike the hard calcium carbonate rich water that created the fossils. Calcium carbonate is naturally attracted to the zinc that coats galvanized CSP. As water flows over the pipe surface, calcium attaches itself creating a natural build up or scale. This scale locks in the zinc and at the same time protects the zinc from corrosive elements in the environment. The scale is visible as a grey crust on pipe inverts below the water line. At some older installation inspection sites, where the crust was scraped away with a knife, the zinc is still shiny.

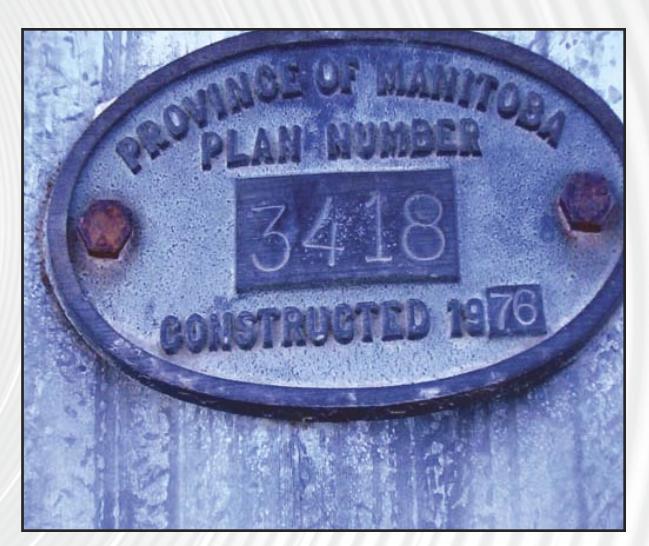
DATE PLAQUE ON HIGHWAY CULVERT

Galvanized Corrugated Steel Pipe was first manufactured in Manitoba in 1908. Culverts from that era to the present remain in service and are performing well today. It is not uncommon to find old salvaged pipe reinstalled at new locations, as roads are widened and improved. Attaching date plaques to Manitoba highway culverts, started in 1950s and continues as part of an ongoing monitoring programme.
