ADDED LONGEVITY WITH THERMOPLASTIC POLYMER COATED STRUCTURAL STEEL PLATE

Submission Date: November 15, 2012

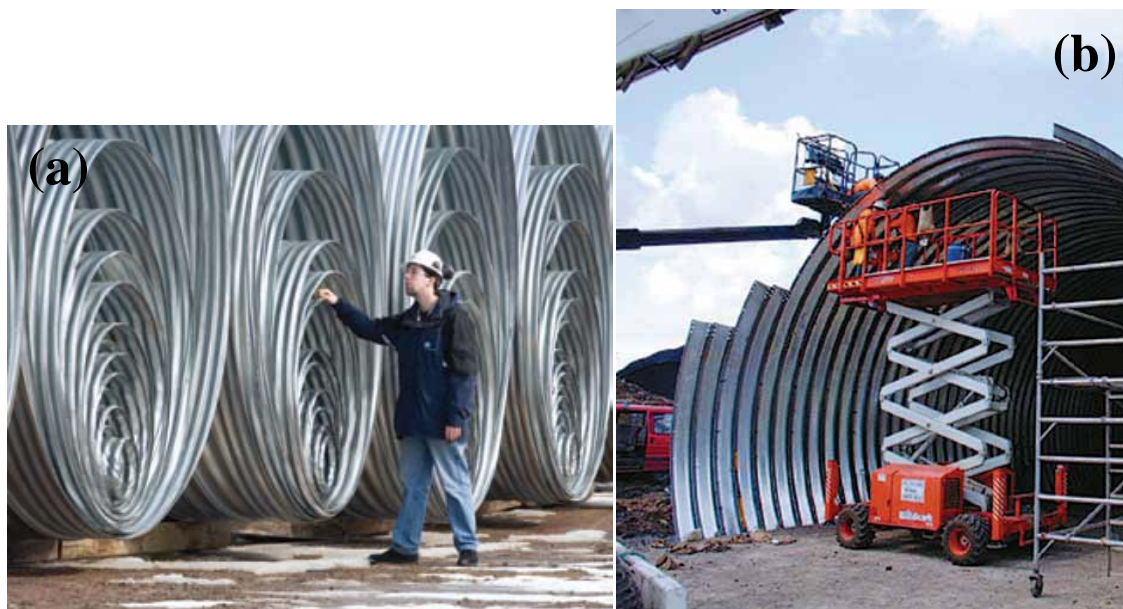
FIGURE 1 (a) Corrugated steel pipe. (b) Structural plate corrugated steel pipe (5).

There are two forms of steel infrastructure discussed in this paper: corrugated steel pipe (CSP) and structural plate (SPCSP). Both are depicted in Figure 1. The following subsections provide more details on the differences and similarities of these two classifications of steel pipe.

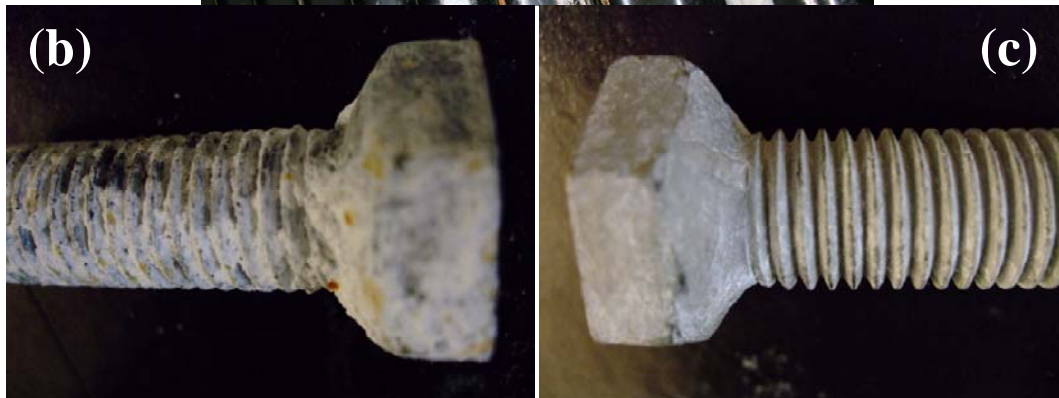
FIGURE 4 (a) Example of staining in the obvert of a structure coated with the thermoplastic polymer system. (b) Galvanized bolt following removal from test chamber compared to (c) duplex coated bolt at three times the exposure time.

To date, preliminary testing has been completed on HDG and duplex metallic coated bolts. Testing on non-scribed bolts was completed according to ASTM B117 (21) *Standard Practice for Operating Salt Spray (Fog) Apparatus*. Comparatively, the duplex coated fasteners had almost three times the exposure capability of HDG bolts (Figure 4). Further evaluation of these and other fasteners is ongoing.
